3.5 Area 3 North – Cork Rd Bridge to N25

Area 3 includes Midleton Town Centre, southern side of IDL site, the Baby Walk, People’s Park, areas adjacent to Dungourney River and Bailick Road. The area is at risk of fluvial flooding from the Owenacurra and the Dungourney, as well as tidal flooding.

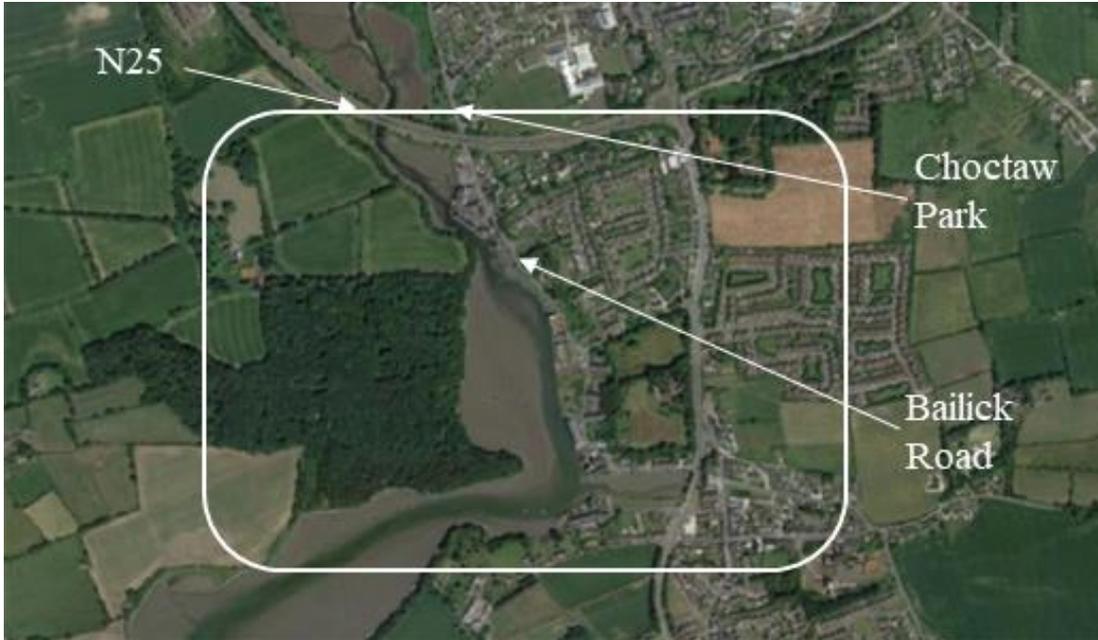
Figure 82: Area 3 South

As discussed in Section 3.5.2, there were reports of shallow overland flow flooding on the Bailick Road coming from North of the N25. There were no reports of any flooded properties during the event. Flow travelled South along the Bailick Road and entered the estuary at the exiting boat slip on the Bailick Road.

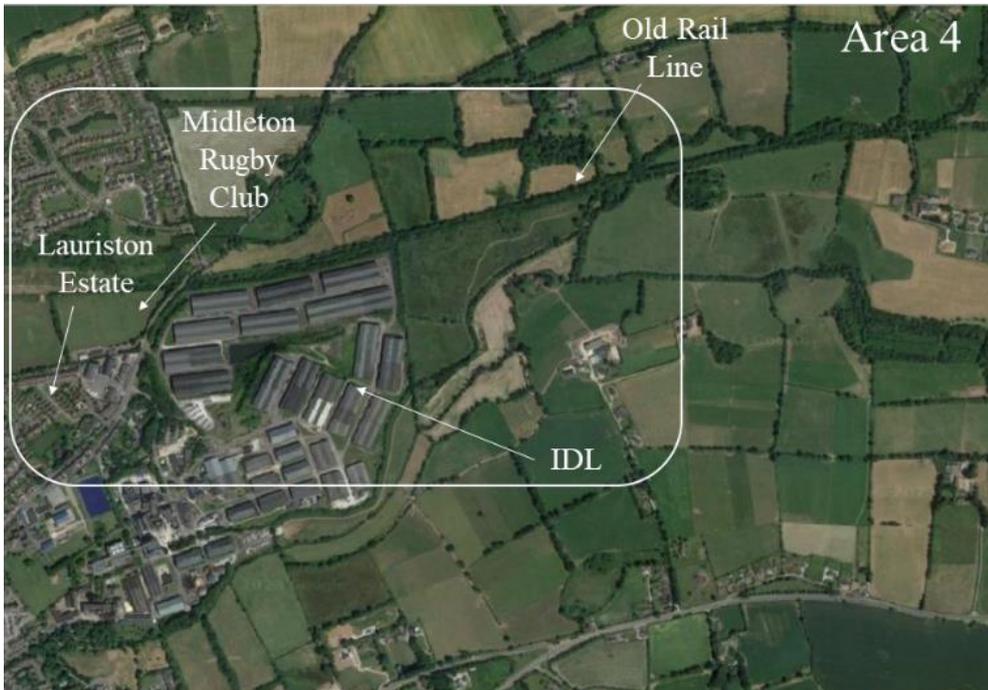
Figure 83: Area 4

There were no reports of properties flooding from groundwater/ fluvial sources in this area during Storm Babet. The Green Way, Midleton Rugby Club and agricultural lands to the East of the IDL Site were flooded. The estimated flood extent from Storm Babet is presented in Figure 84.
