JBA
consulting

Hydromorphic audit of the River Glashaboy

Final

November 2016

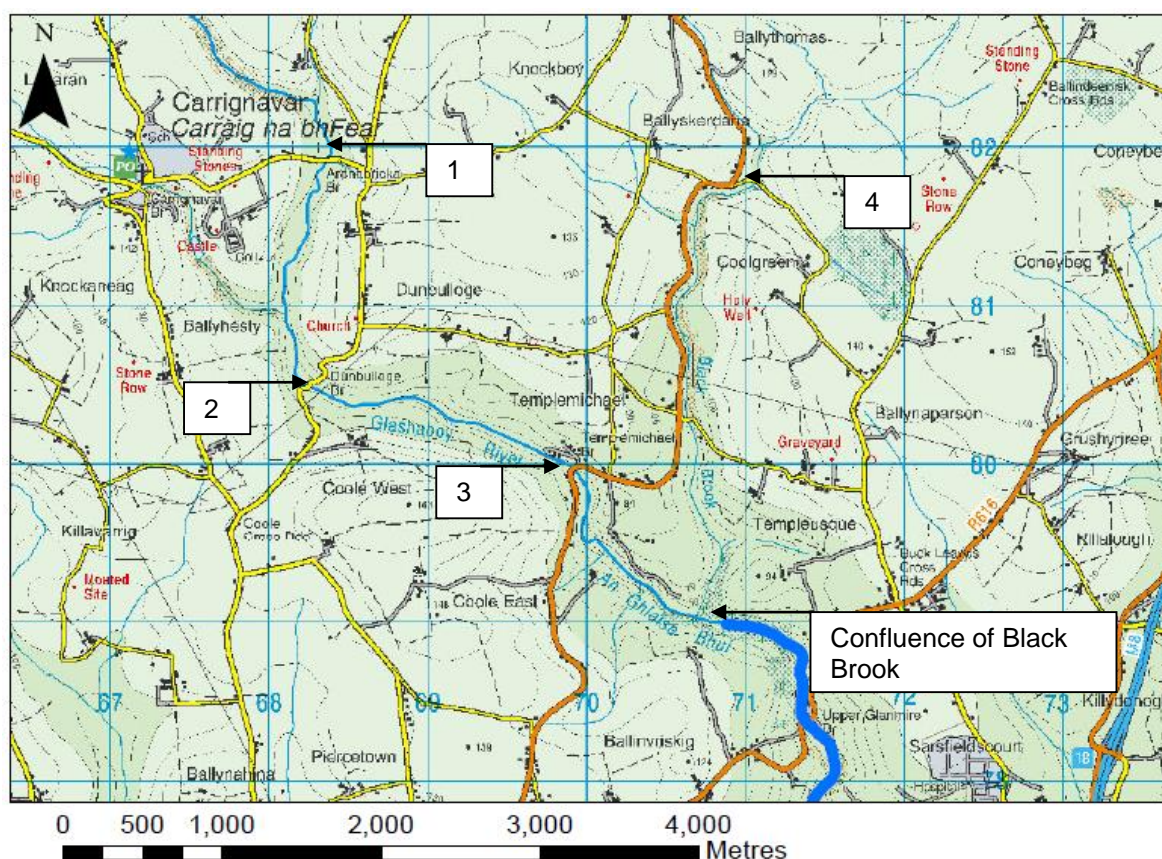
Figure 3-1 Survey Reach Overview

The upper sections of the Glashaboy between Carrignavar to Upper Glanmire Bridge (1 to 2 on Figure 3-1) are predominantly rural. The floodplain in most locations is narrow and dominated by farmland and woodland. The channel exhibits a pool-riffle morphology which is dominated by a cobble and gravel bed, with little evidence of significant transport of cobble and gravel sized material given the amount of bed algae present across this sediment (Figure 3-2). Limited large accumulations of gravel as bar features were noted even in areas where the gradient was reduced. This suggests a limited upstream supply of gravels and/or the ability of the channel to flush sediment downstream during higher flow events.

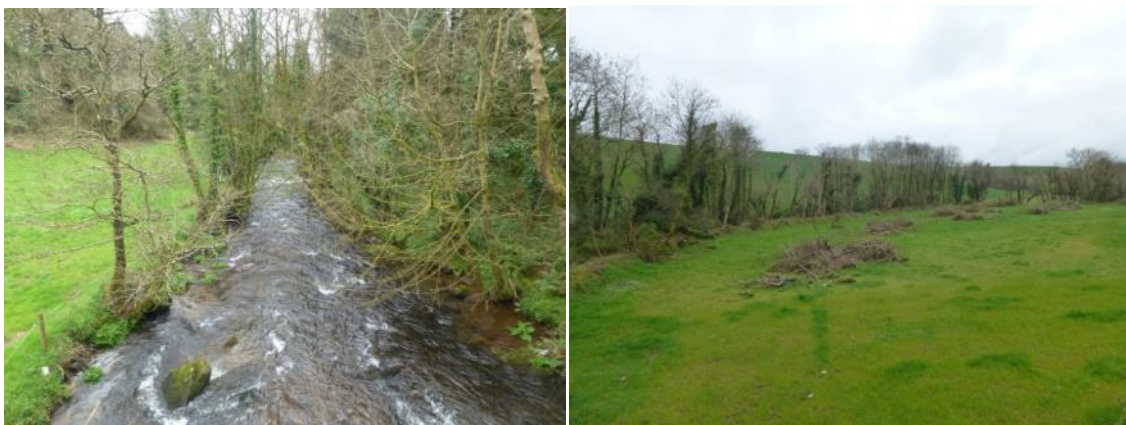
Figure 3-3 Dunbulloge Bridge (Point 2)

Evidence within the reach of historic channel management exists, including old dredging embankments (Figure 3-3) and channel straightening. Channel straightening and dredging has led to some disconnection of the channel from its floodplain in certain areas (although this is not excessive in the upper reaches). Modifications to the channel such as dredging and straightening

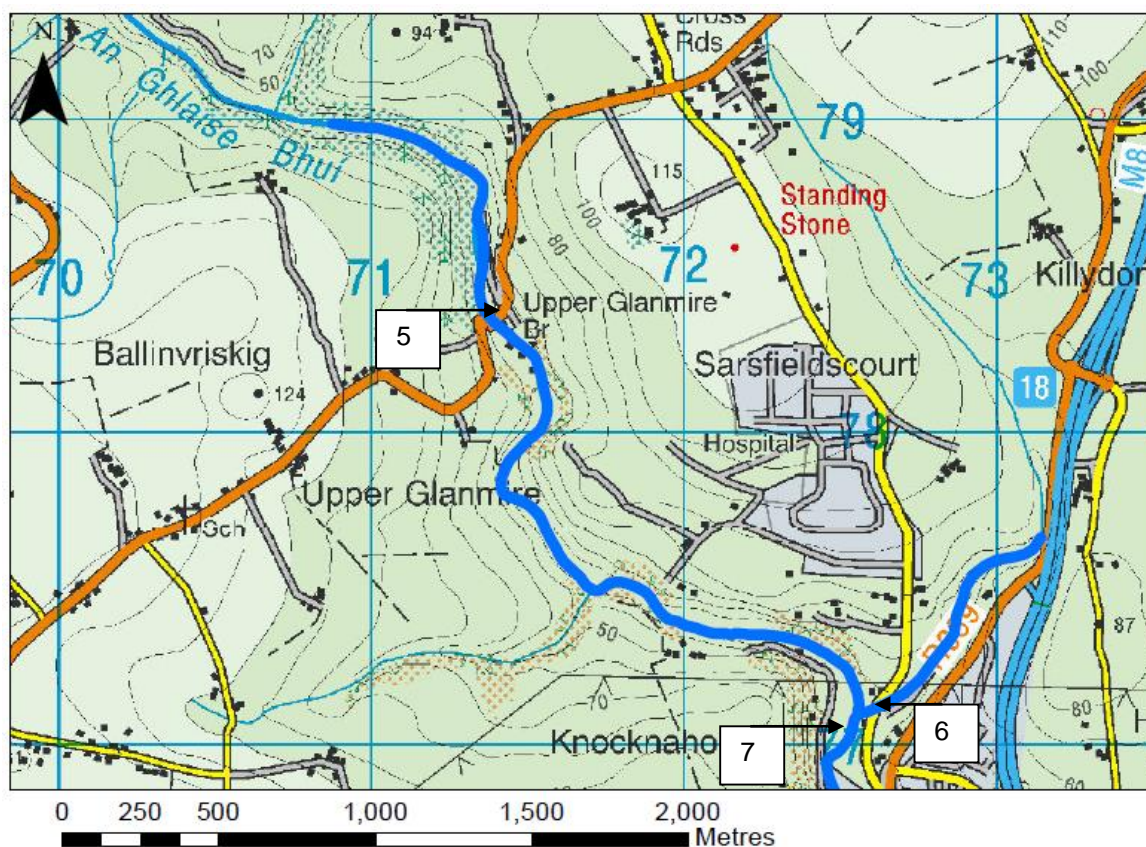
In the reach between Upper Glanmire Bridge and Knocknahorgan the river valley narrows which results in a confined floodplain. At Upper Glanmire Bridge a weir is leading to local bank erosion (Figure 3-6), due to the direction of flows passing under the bridge. Banks have been reinforced using gabion baskets, however, in the long term the river may undercut these baskets.

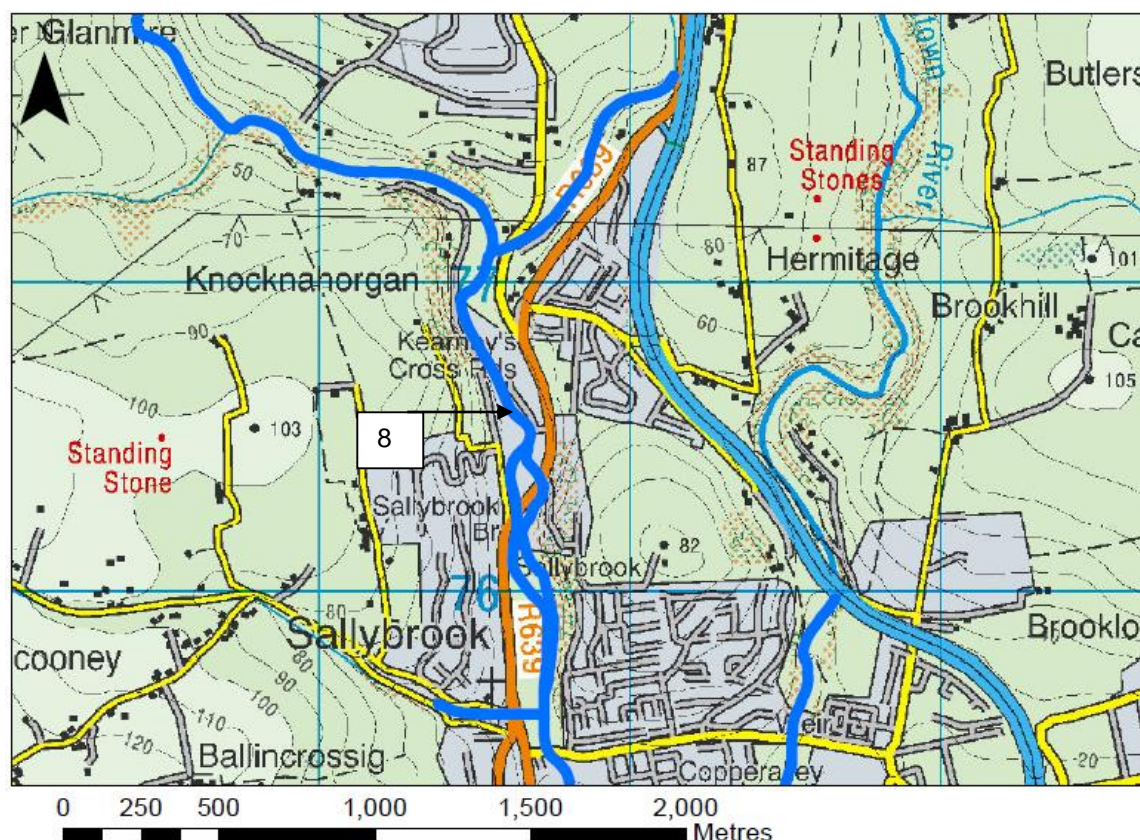
Figure 3-9 Reach overview

As the river approaches Sallybrook the channel and its floodplain become subject to greater urban influences including embankments, weirs and limited floodplain connectivity due to the presence of flood embankments.

As the channel approaches Sallybrook the valley widens and becomes less confined. The wider floodplain along this reach has been developed / built upon which acts to constrict the channel. In some areas informal flood embankments have been constructed. In other areas active bank erosion is occurring as the channel attempts to naturally adjust within its confined channel. This is exacerbated by the higher energies during flood conditions as a result of the channel constriction. Hard measures, such as walls have been constructed to reduce the erosional impact of the river (particularly on the outside of bends) and some of these are now failing (such as adjacent to the petrol station). The erosion of banks acts as a strong sediment supply of gravels and fine materials. Deposition is also common through this reach, with several gravel bars (which are unvegetated, signalling frequent movement) being present. However, in the lower portions of the reach the channel becomes incised as a result of the influence of old mill leats and weirs (some existing and some now removed). As a result of these structures the channel is disconnected by over 1m from the floodplain (due to the channel eroding downwards in an attempt to adjust its bed gradient) and deposition is minimal, due to floodplain disconnection and high in channel energy levels. The channel in this lower section is dominated by coarser cobbles.

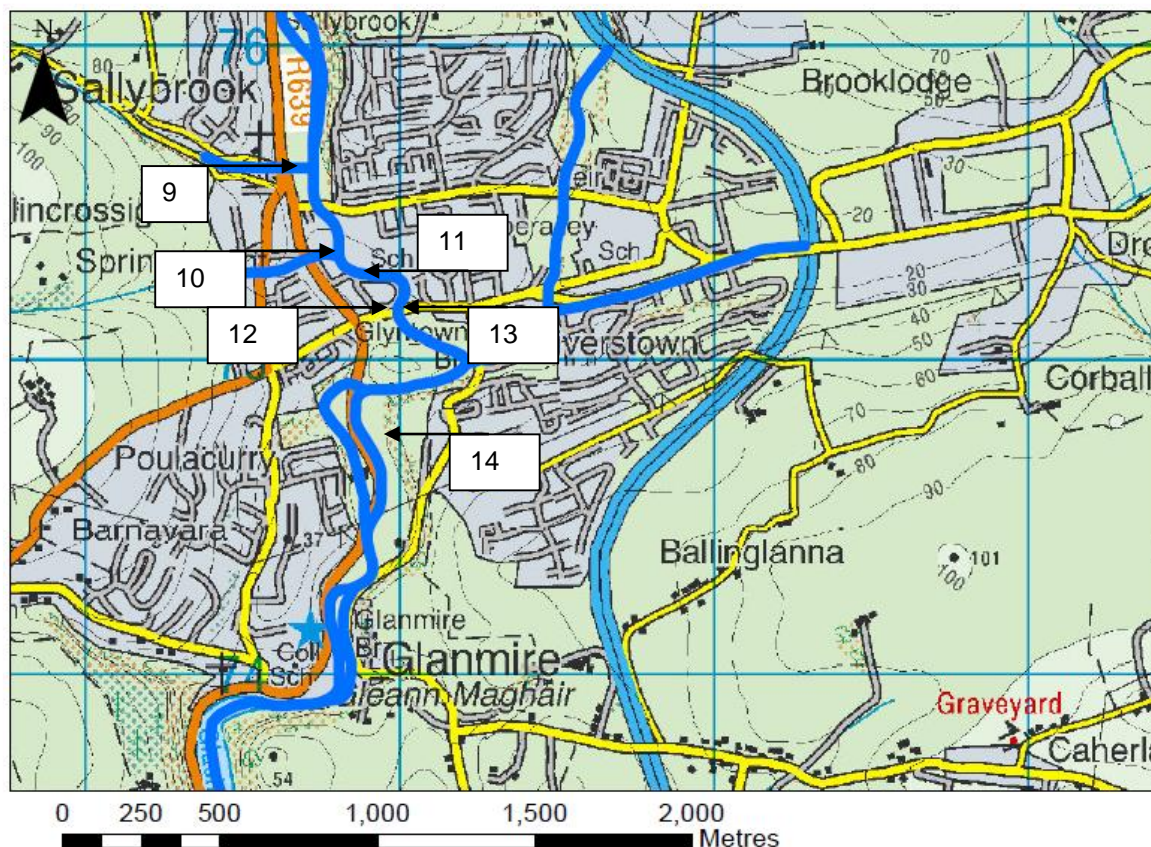
Figure 3-11 Reach overview

Downstream of Sallybrook the channel flows through a narrow urban corridor. The channel remains slightly incised, possibly due to historic straightening due to protected river banks. Sediment is delivered to this reach via several steep tributaries.

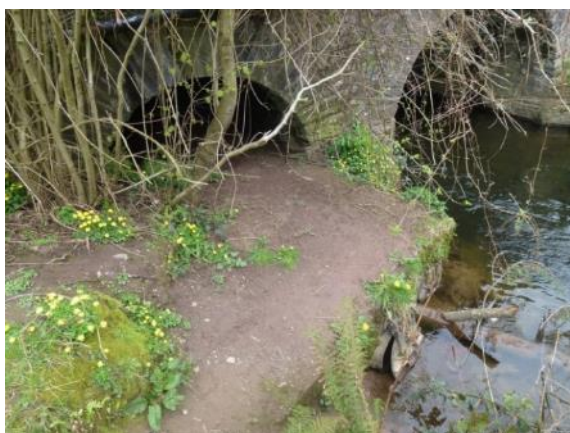
Figure 3-16 Upstream of the park (Point 12)

Downstream of the housing estate the channel enters a parkland area and connection to the floodplain is improved. In areas of the channel where flows are reduced fine sediment deposition is occurring (Figure 3-16) and in some areas small pockets of gravels (Figure 3-17) have been deposited, however, gravel deposition is not widespread. If sediment is removed as part of any future maintenance works, it should be expected that sedimentation will re-establish itself naturally.

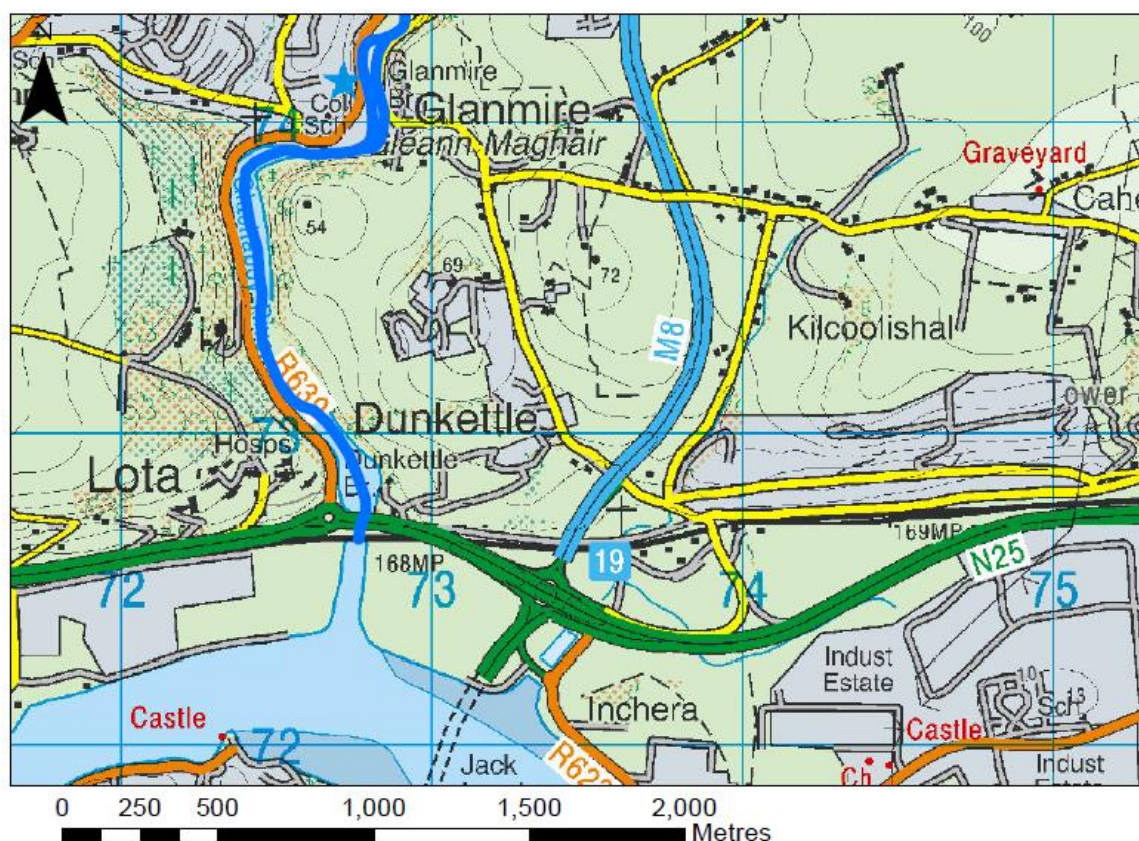
Figure 3-19 Reach overview

At Glanmire bridge, deposition of gravels is occurring on the left bank (Figure 3-20). Downstream of the bridge the river gradually becomes wider and eventually is influenced by the tidal regime. This influences water levels and flow conditions downstream of Glanmire, resulting in some deposition of tidally derived muds and silts. The deposition of this sediment appears low therefore there is little risk of increased sedimentation in this section.
