Glashaboy River (Glanmire/Sallybrook) Drainage Scheme

Issued for Confirmation May 2018

Drg. No. GR_217 Proposed Flood Defences - Plan Layout (Sheet 17 of 17)

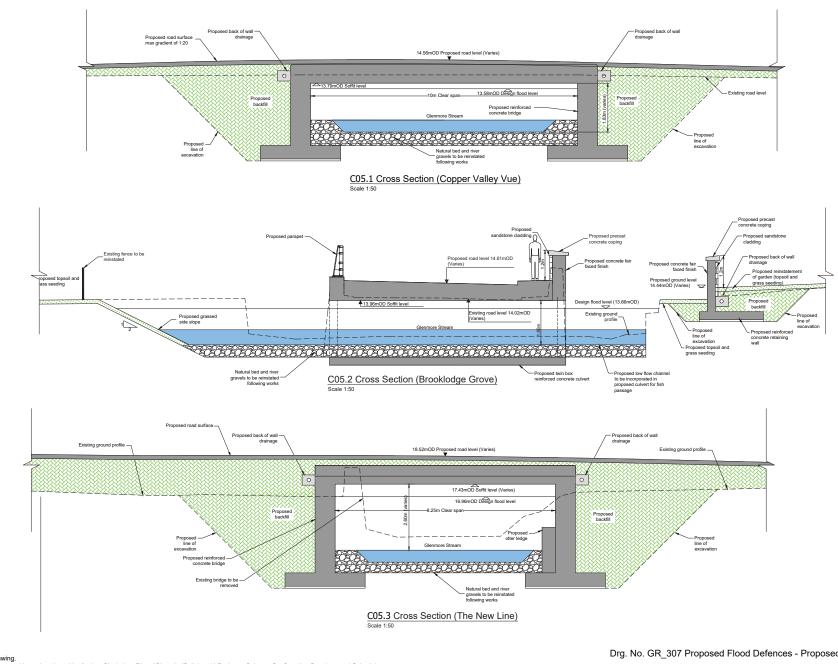
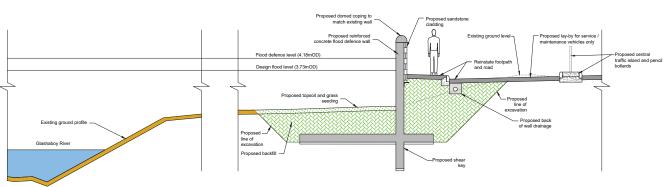
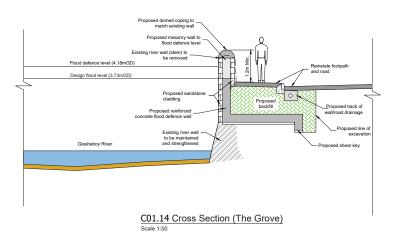
Do not scale from drawing. This drawing should be read in conjunction with all other Glashaboy River (Glanmire/Sallybrook) Drainage Scheme Confirmation Drawings and Schedules. Drg. No. GR_307 Proposed Flood Defences - Proposed Sections (Sheet 7 of 8)

C01.13 Cross Section (The Grove)

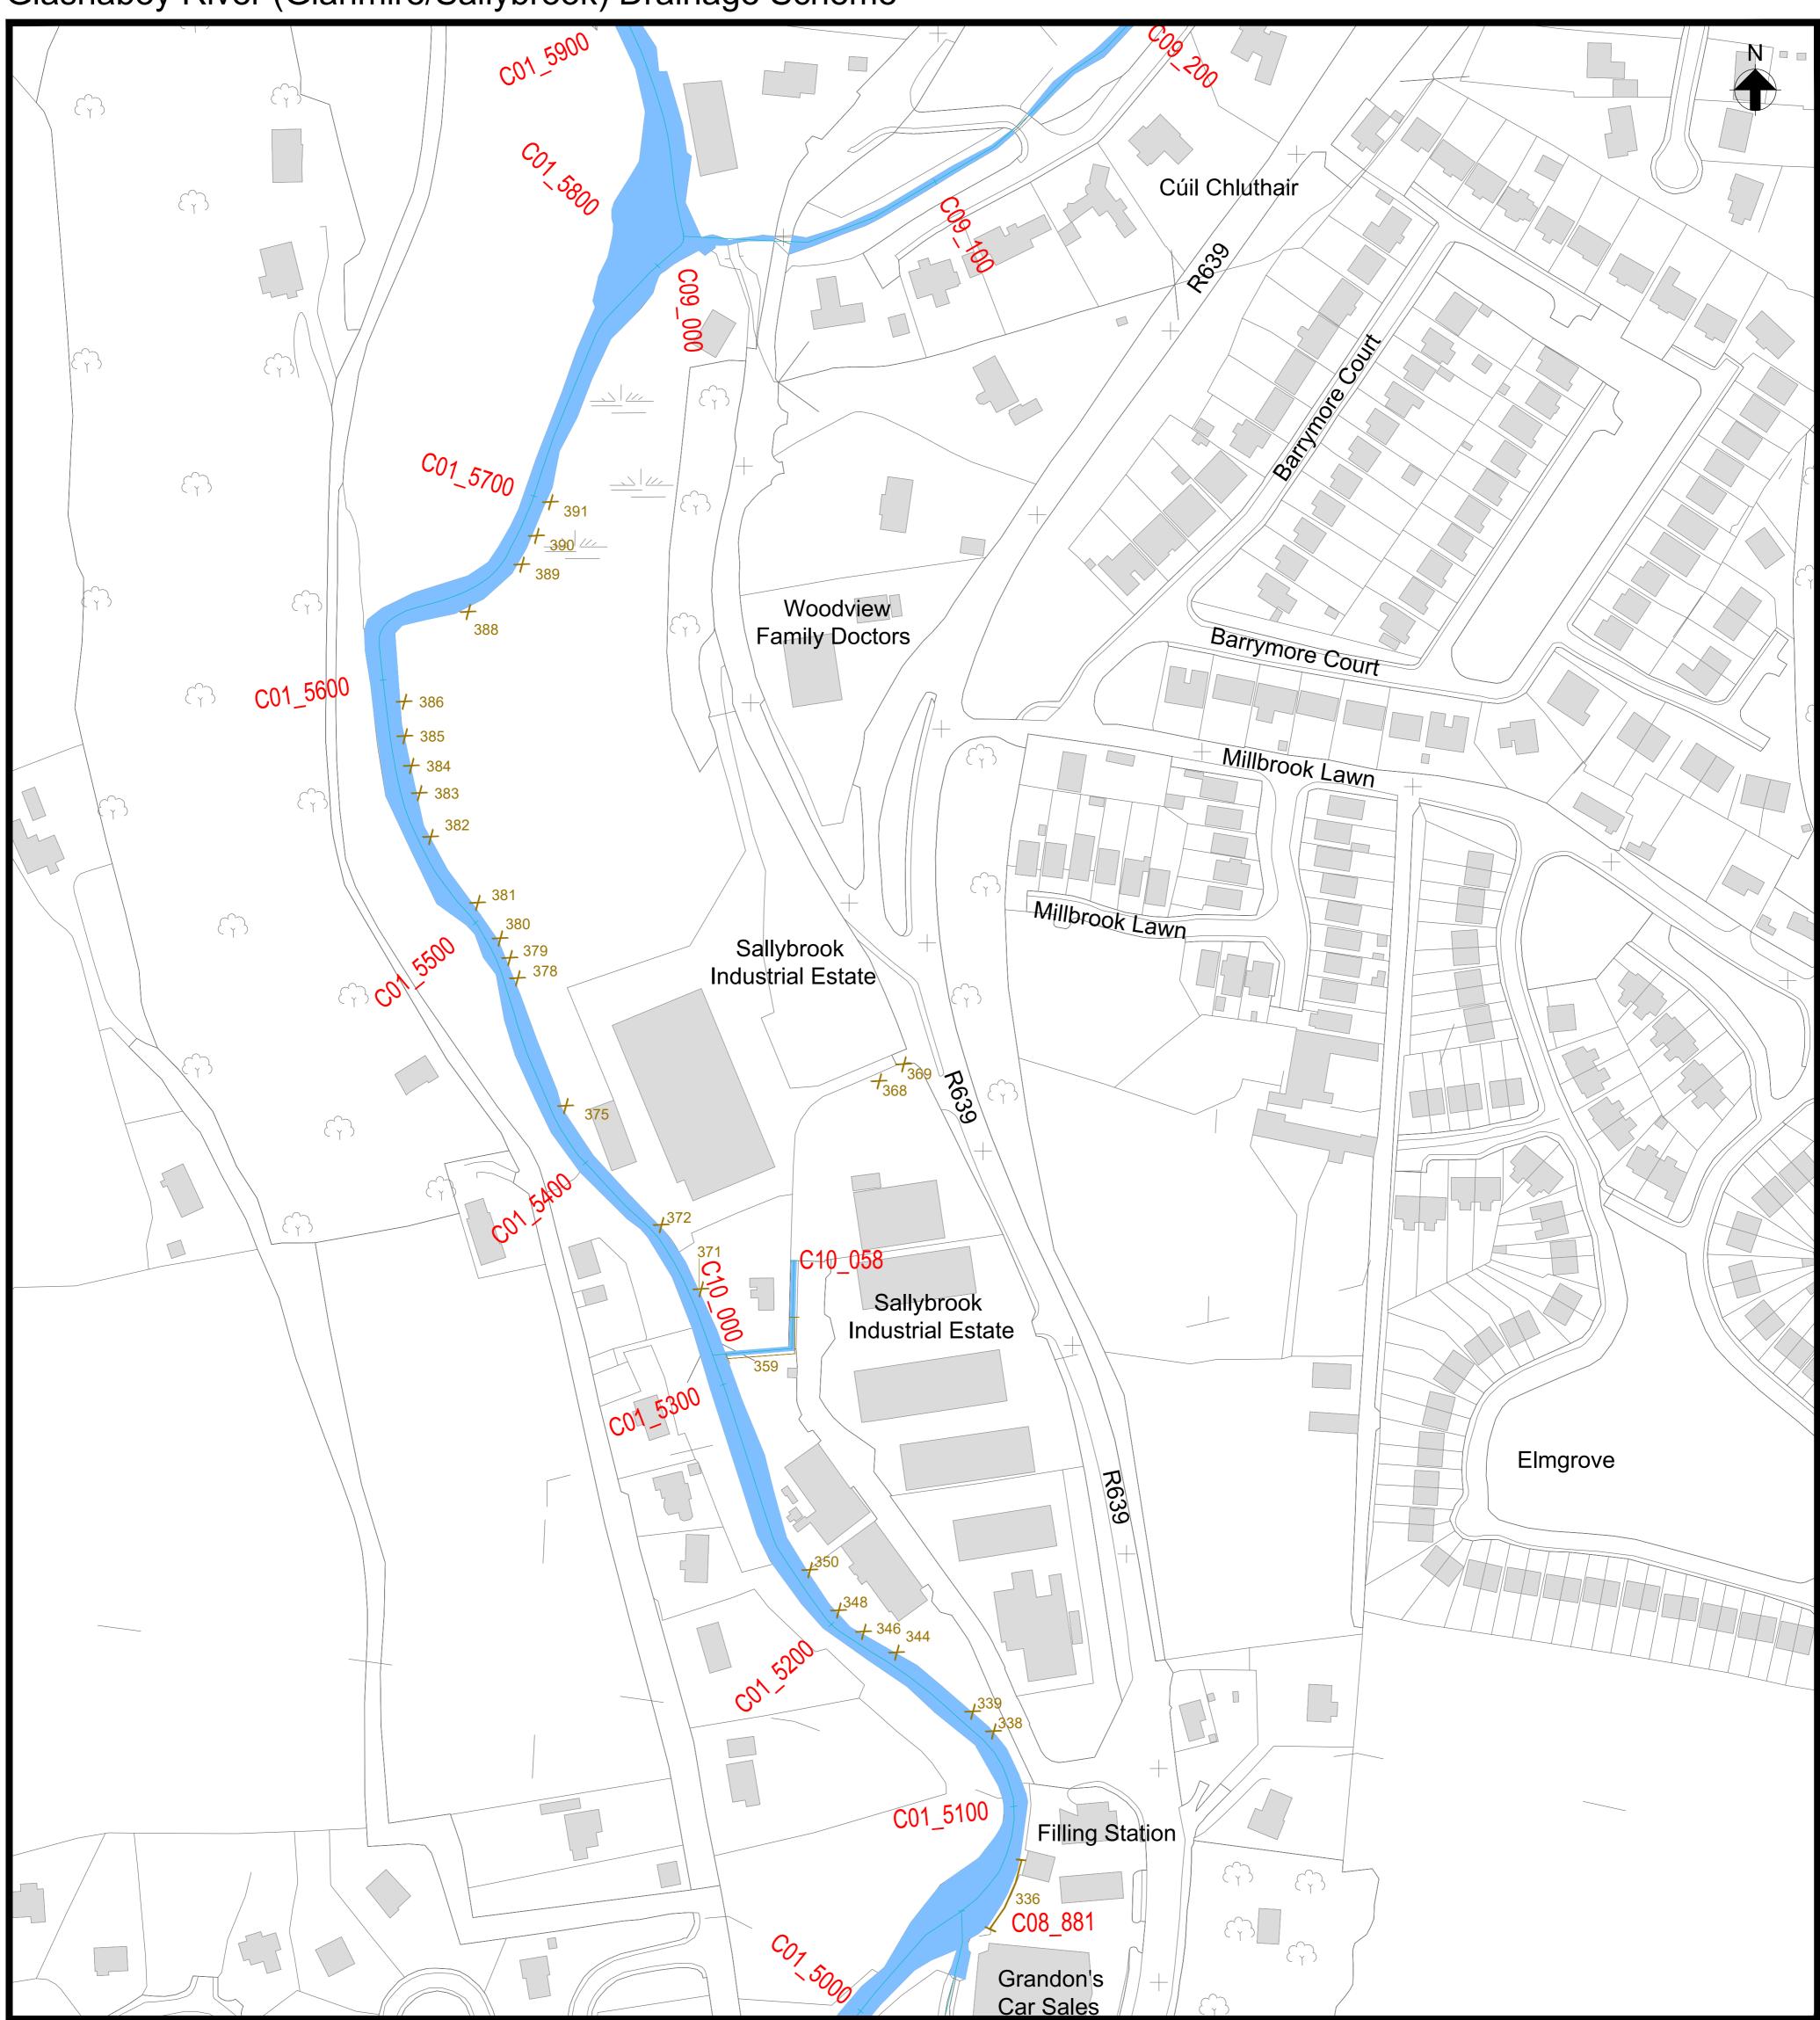
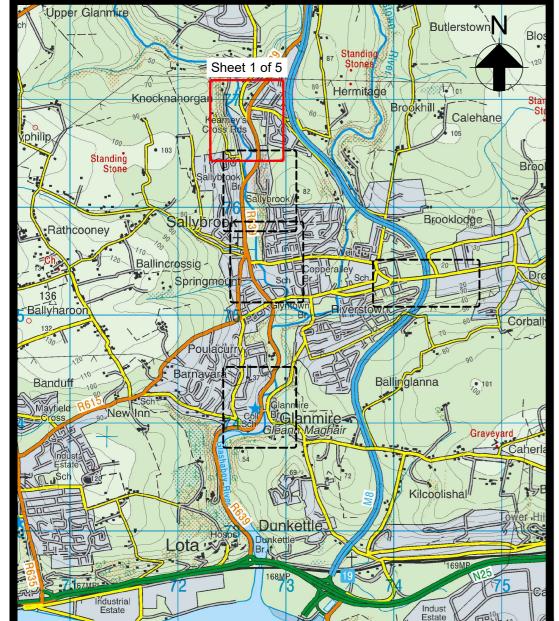
Tree Removal Drawings

Key to Plan Trees to be Removed **/##** Channel Centreline, Reference (C06) and Chainage (300m) C06_300
