Public Participation | Day No.3

Area 6 Upstream of Water Rock Cave System / Underground Watercourse

The objective Provide flood risk mitigation to the design

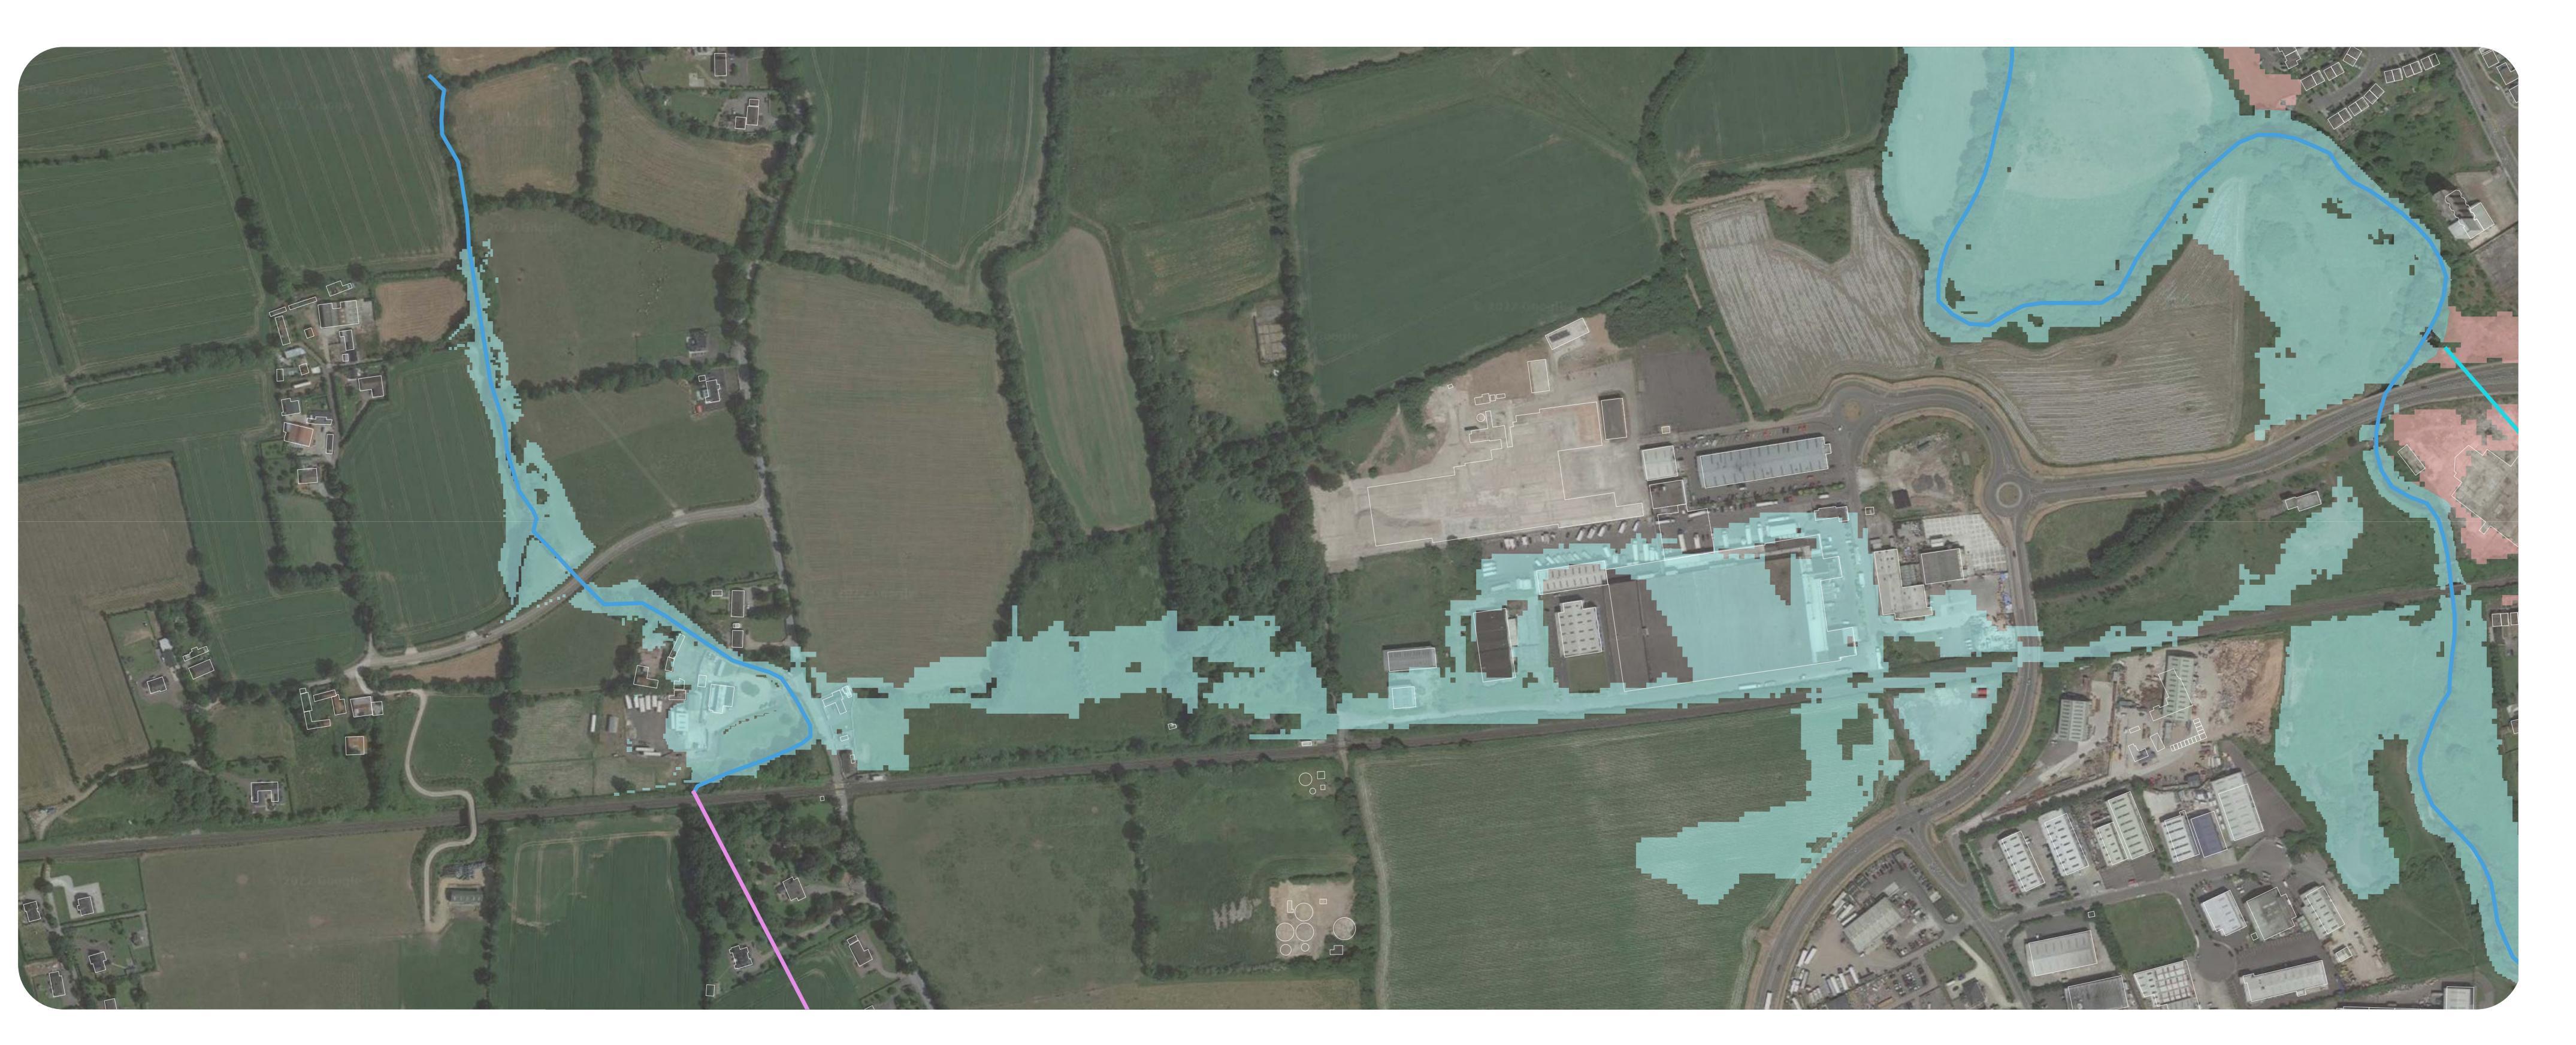
1% AEP Fluvial/ 0.5% AEP Tidal Flood Extent (1 in 100 year fluvial/ 1 in 200 year tidal flood extent)

If/when groundwater levels in the cave system rise (for example following prolonged rainfall events), this acts as a 'blockage' to the watercourse and water levels within the stream increase. This causes flooding of the area as shown in the figure.

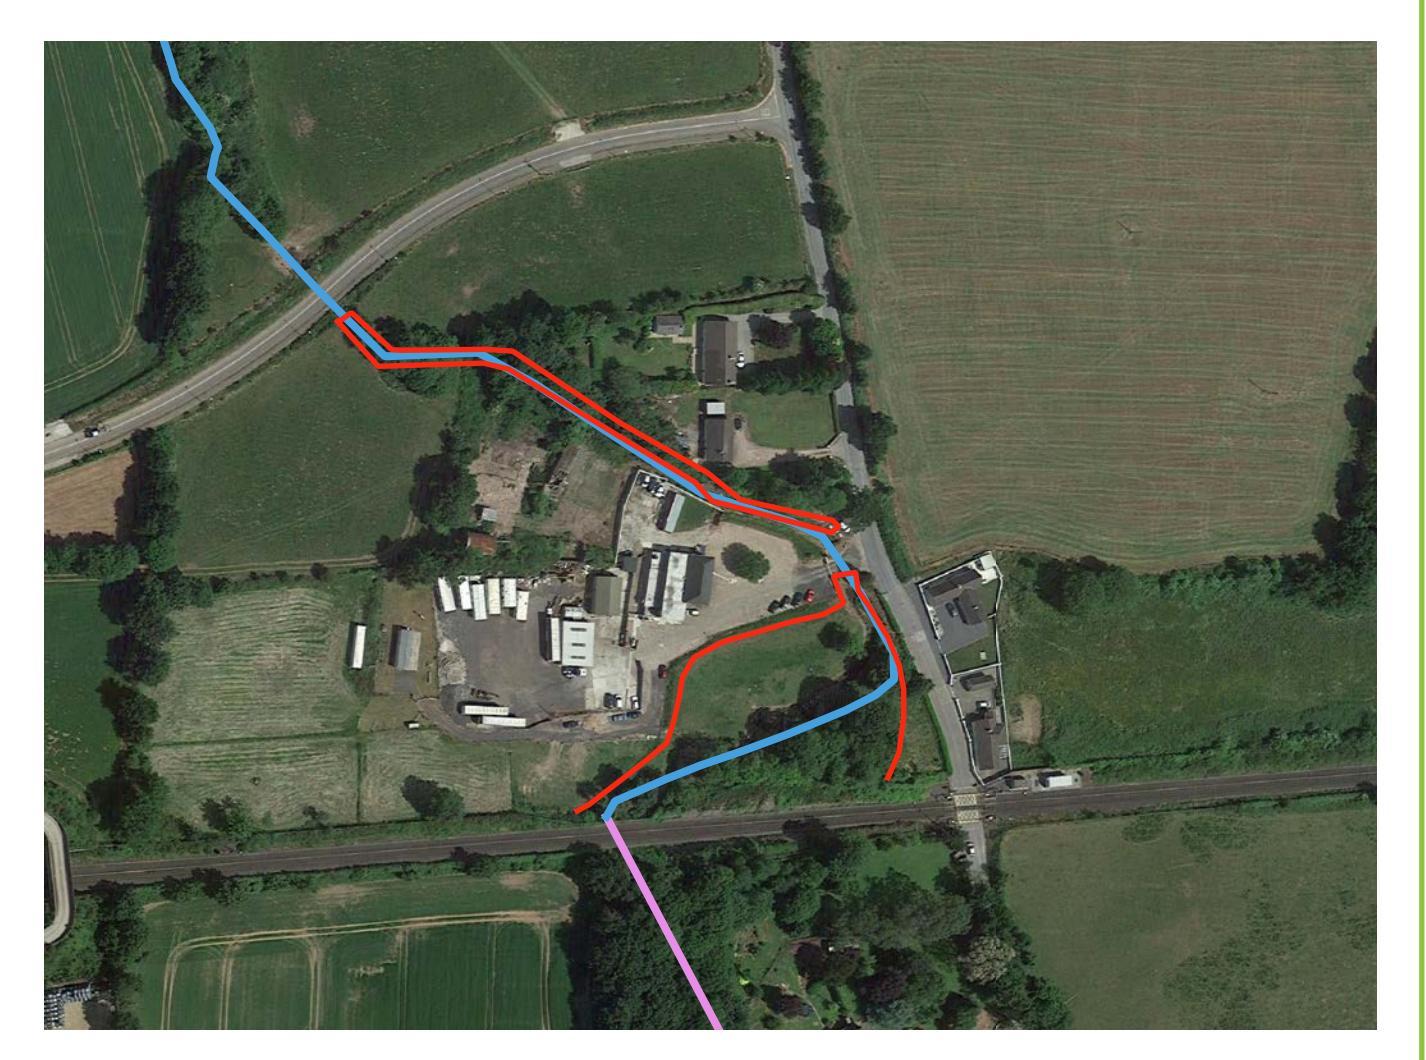
Direct defences

Not considered viable for following reasons:

- Excessively high defences required and are located adjacent to existing residential properties (greater than 3.5m high)
- Negative impact on landscape and visual
- Limited scope for climate change adaptability
- Standard of protection is not provided due to capacity of the cave system being unknown

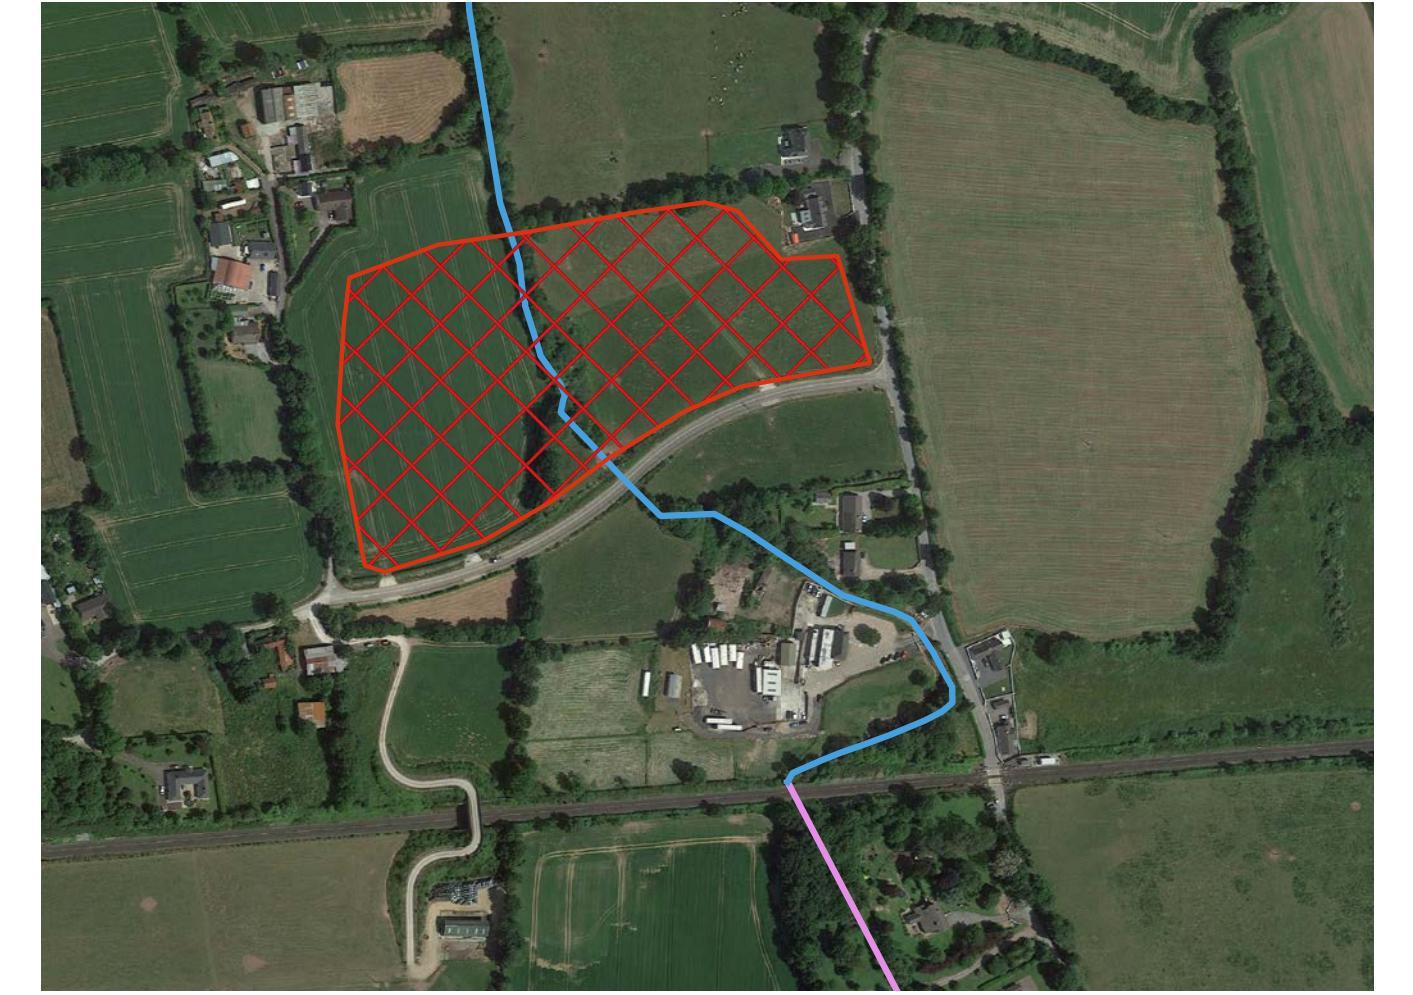
Upstream storage

Not considered viable for the following reasons:

• Standard of protection is not provided due to capacity of the cave system being unknown

- Excessively high impoundments embankments (+3.5m high) required
- Flood warning system not feasible
- Limited scope for climate change adaptability

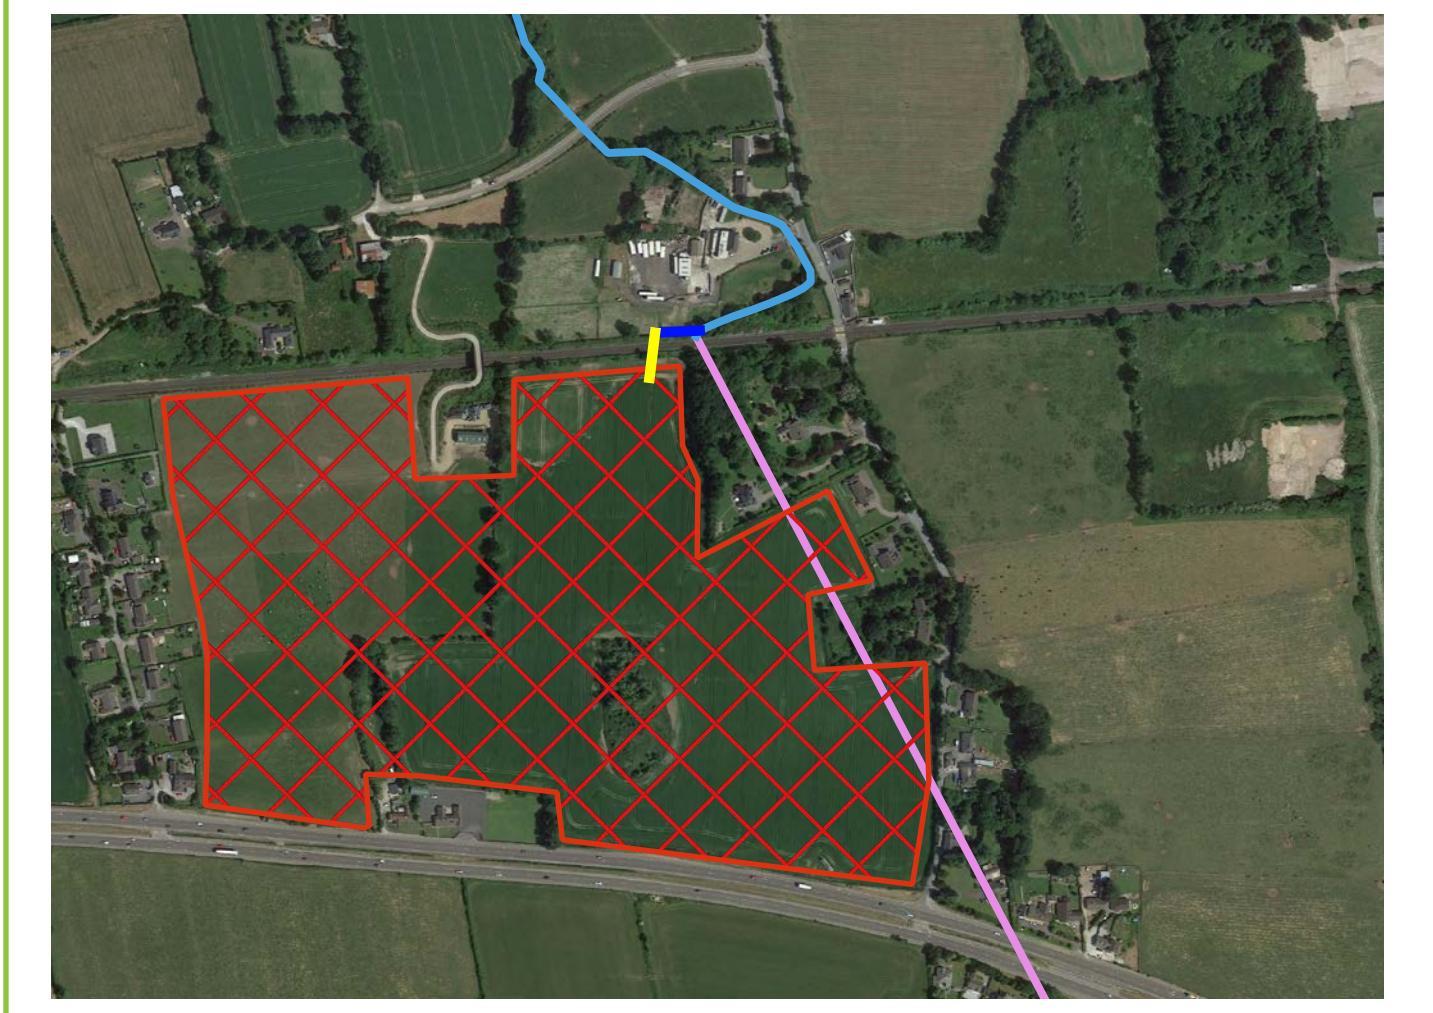
Culvert under railway line to west of Water Rock House and storage to west of cave system

Not considered viable for the following reasons:

- Standard of protection is not provided due to capacity of the cave system being unknown
- Introduction of flood risk to properties to the west, requirement for additional defences
- Difficulty draining the land following flood event
- Flood warning system not feasible
- Construction under railway line required
- Limited scope for climate change adaptability

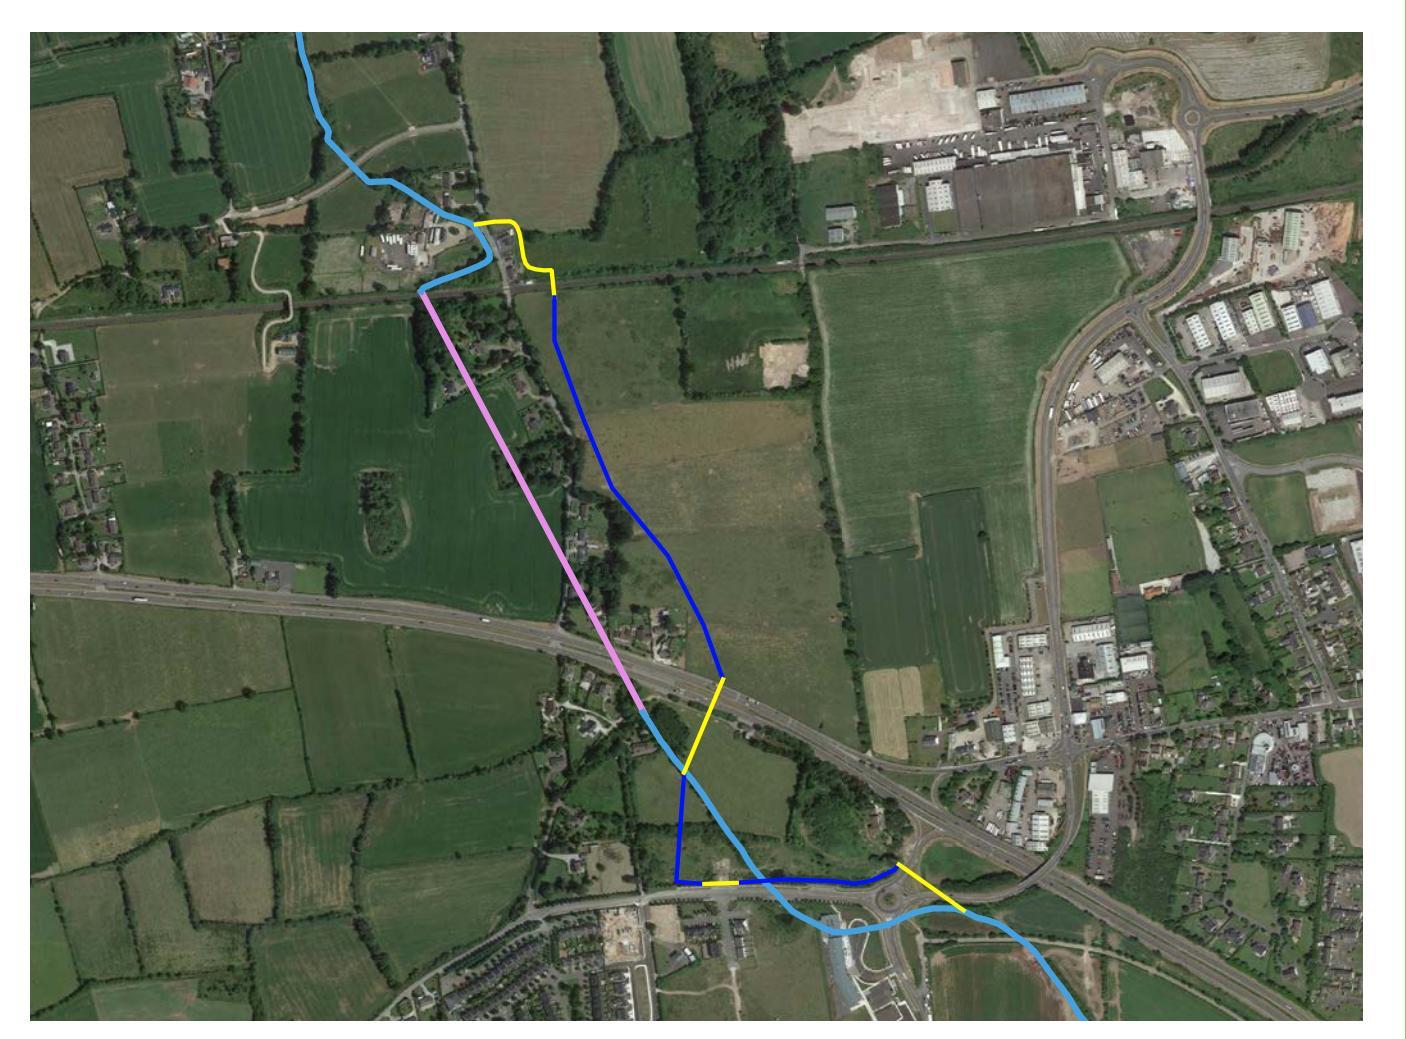
Flood diversion channel/culvert

Although the standard of protection is provided, this option is not considered viable for the following reasons:

- Significant costs, resulting in an option that is not cost beneficial
- Significant construction complexity crossing under the railway line and the N25 road

• Increase of flood risk downstream

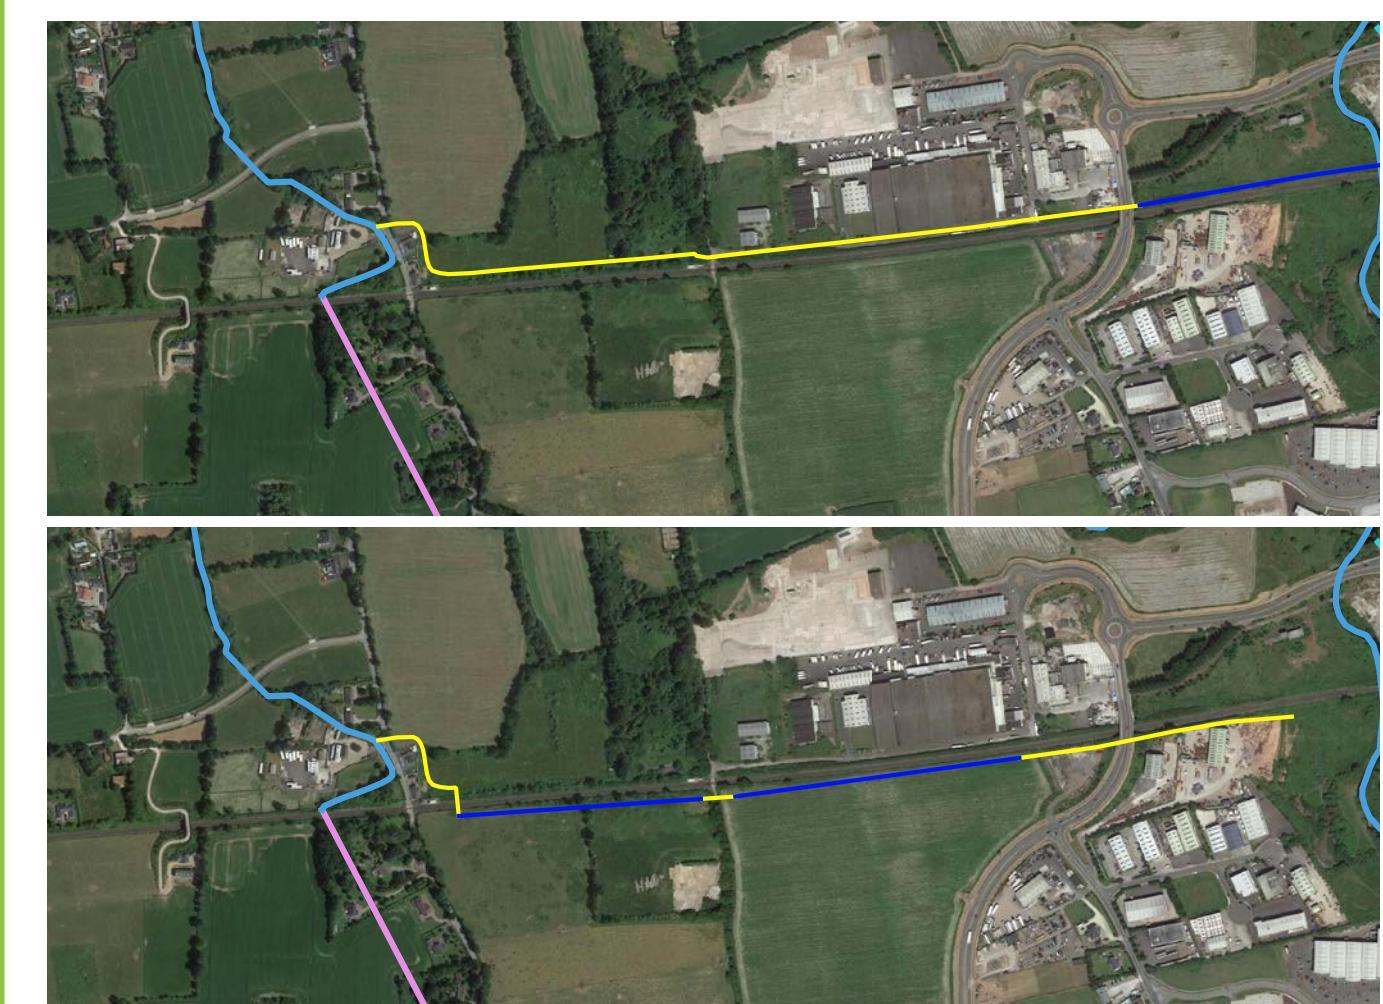
Flood diversion channel/culvert to the south to discharge into the Water Rock stream downstream of the cave system

Although the standard of protection is provided, this option is not considered viable for the following reasons:

- Significant costs, resulting in an option that is not cost beneficial
- Significant construction complexity crossing under the railway line and the Northern Relief road
- Significant interaction with existing and proposed utility infrastructure adding to construction complexity

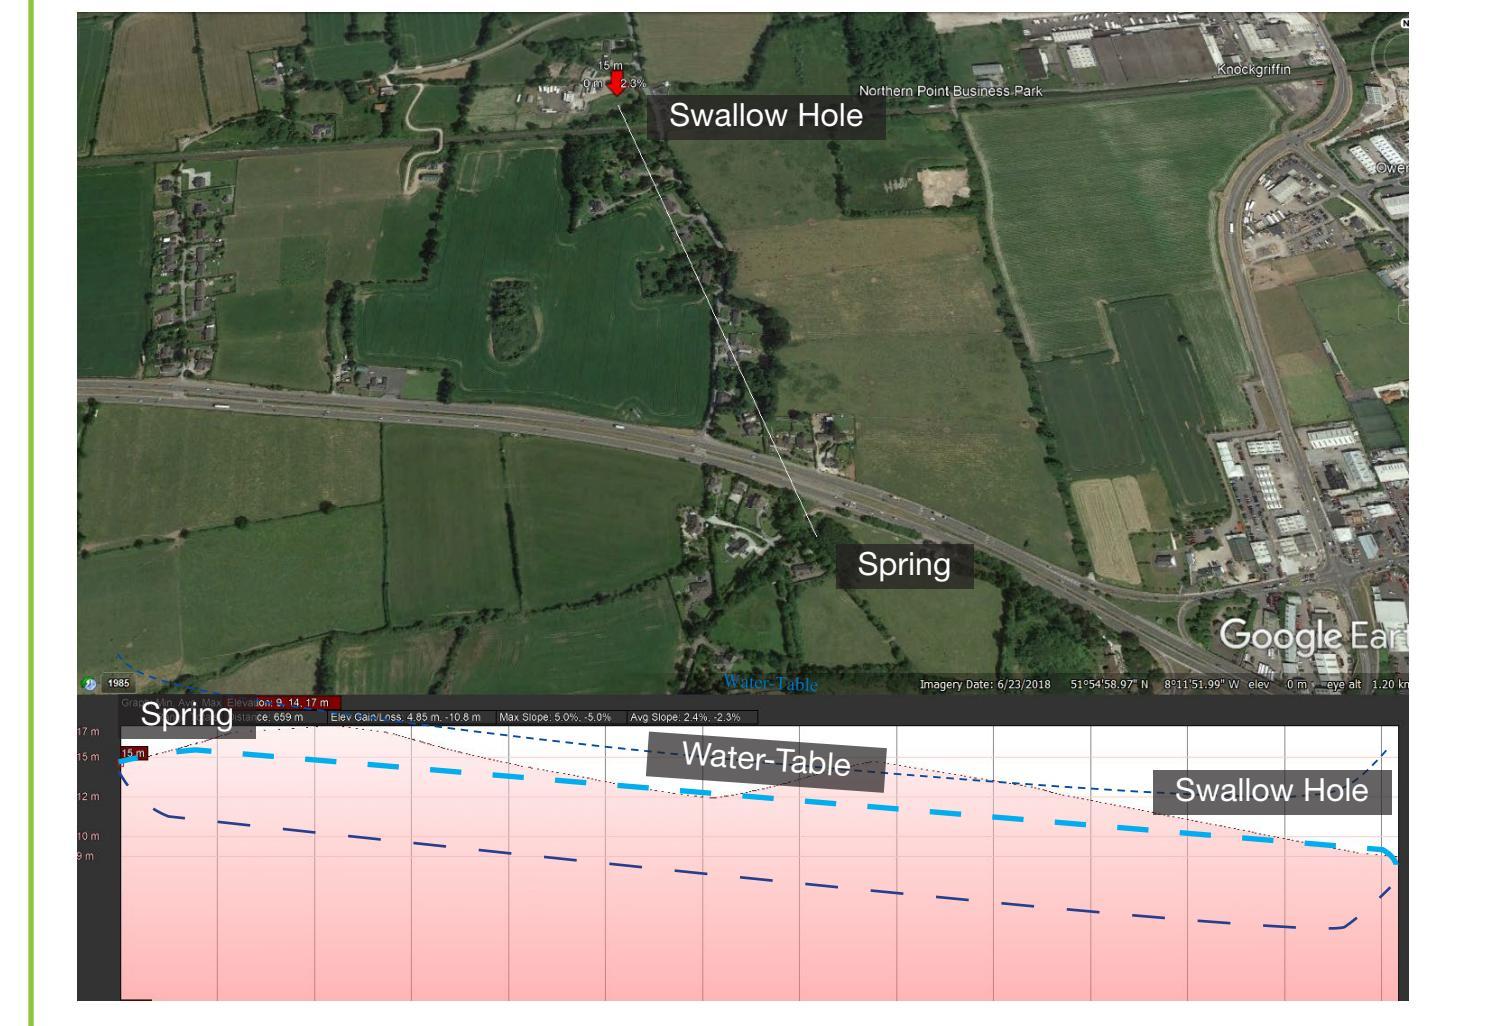
Horizontal Directional Drilling (HDD)

Although the standard of protection is provided, this option is not considered viable for the following reasons:

- Significant costs, resulting in an option that is not cost beneficial
- Significant construction complexity
- Potential environmental impacts
