Midleton Flood Relief Scheme

Interim Measures Report

Reference: 252803-71

Issue 1 | 24 June 2024

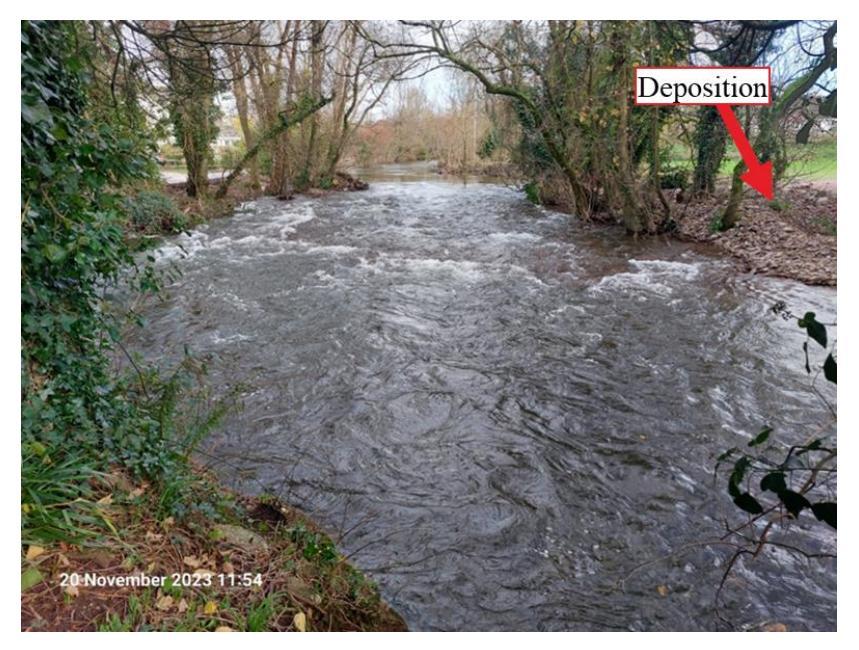
A significant volume of gravel was also deposited on the left bank adjacent to the Willowbank Estate as shown in Figure 3. It is recommended that these gravels are removed in order to improve floodplain conveyance and reduce water levels on the floodplain and hence to reduce flood risk. It is noted that there are no seasonal constraints in doing so.

Figure 3 Deposition of material on the left bank and in channel (photo looking upstream)

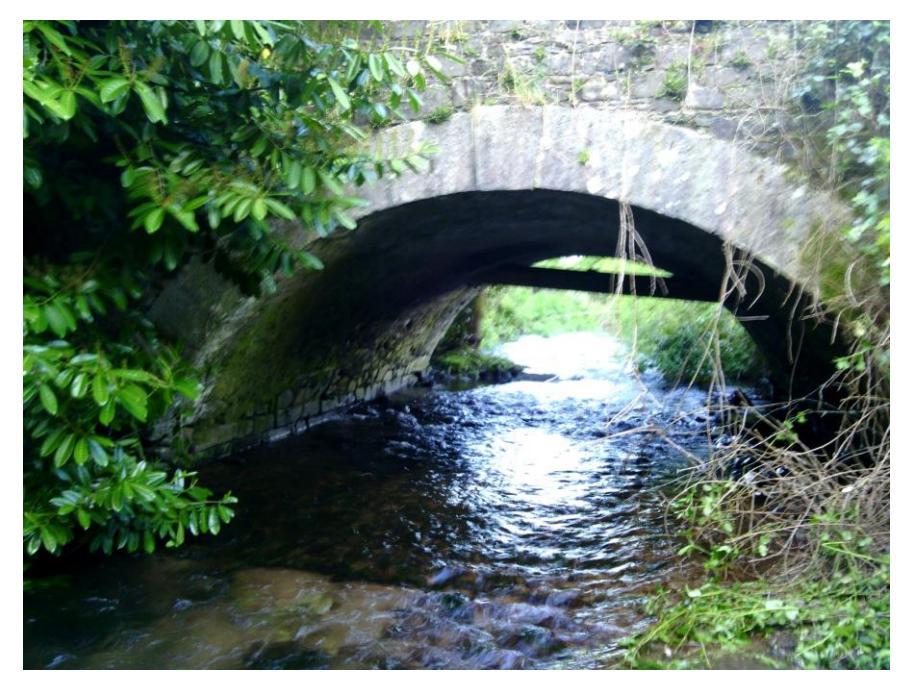
CCC are progressing the diversion of existing Uisce Éireann assets under the Carrigogna Bridge. The existing watermain pipe runs under the Carrigogna Bridge on the R626 passing over the Glenathonacash watercourse, a tributary of the Owenacurra (Figure 4). It and a parallel decommissioned watermain are a hydraulic restriction and potential blockage risk to river flows in flood conditions, and these will be removed and/or diverted as appropriate.

Figure 4 Carrigogna Bridge- Watermain passing under bridge

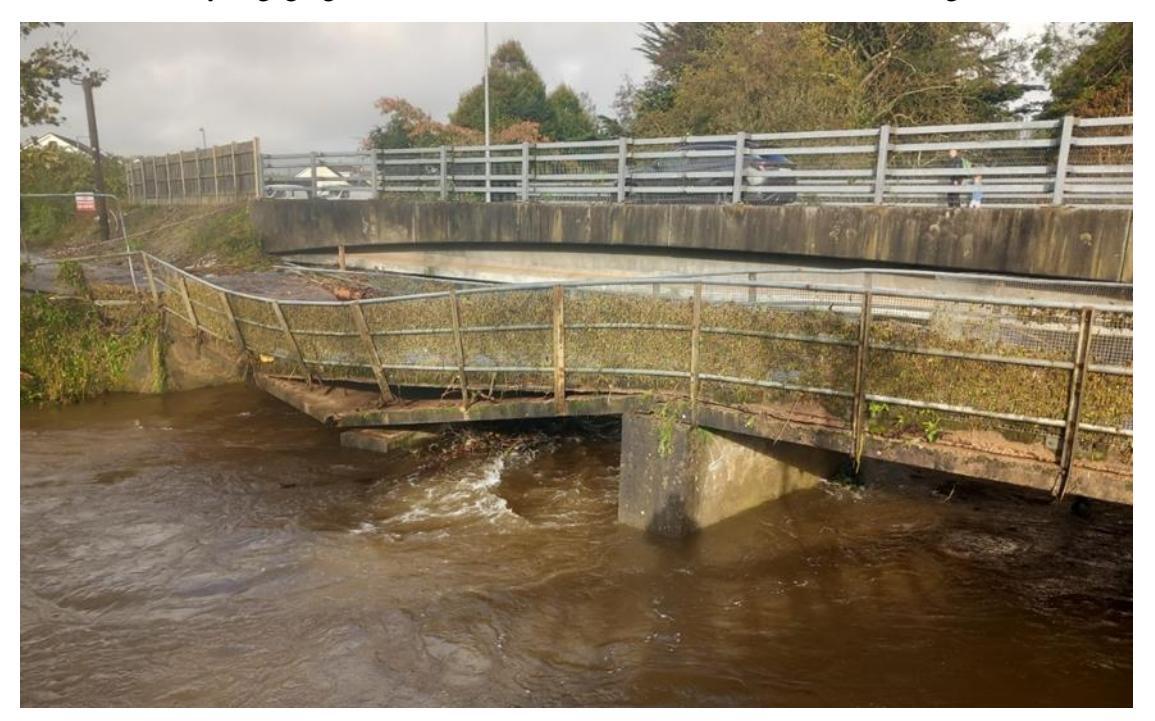
Moore's Bridge was significantly blocked and also partially collapsed during the Storm Babet event (Figure 5). Arup have carried out an assessment of the bridge and it is recommended it be removed as an interim measure in order to reduce blockage/ flood risk locally in this area.

Figure 5 Moore's Bridge Collapse- Image taken post Storm Babet (19/10/2023)

CCC are actively engaging with the relevant landowners in relation to this bridge.

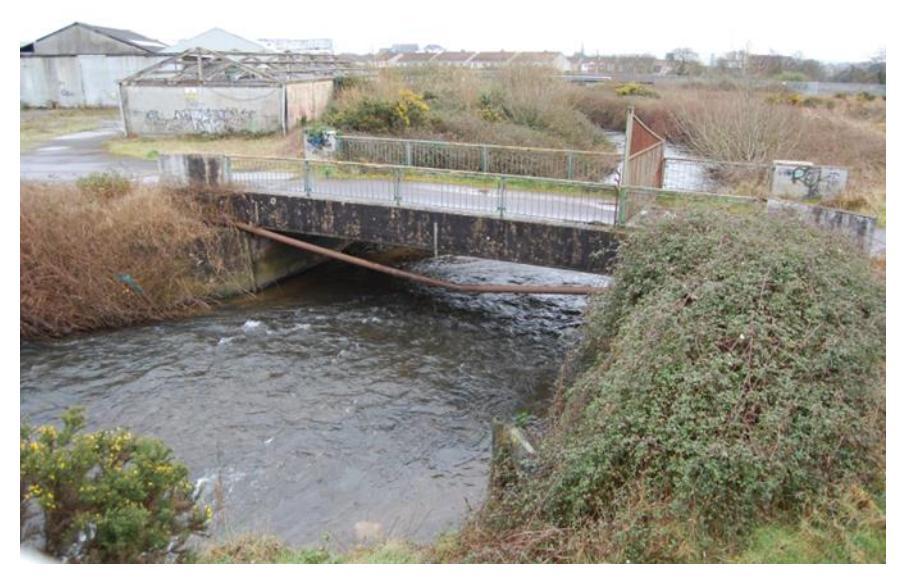
The minor bridge downstream of the Northern Relief Road (Figure 6) was surcharged during the Storm Babet event. Based on inspection of a video captured during Storm Babet and cross referencing it against the surveyed cross sections, the Storm Babet water level was estimated to be circa 9.1mOD at the bridge.

The estimated design water level at this location is 8.4mOD while the surveyed soffit level of the bridge is circa 7.78mOD. As the undersized bridge opening limits conveyance through this section and also introduces a risk of blockage, it is recommended that it be removed.

Figure 6 Bridge downstream of Northern Relief Road Bridge

It is noted that the bridge's existing purpose is very limited as it links two uninhabited sites, both of which have alternative access.

CCC is actively engaging with the relevant landowners to secure agreement for the removal of this bridge.

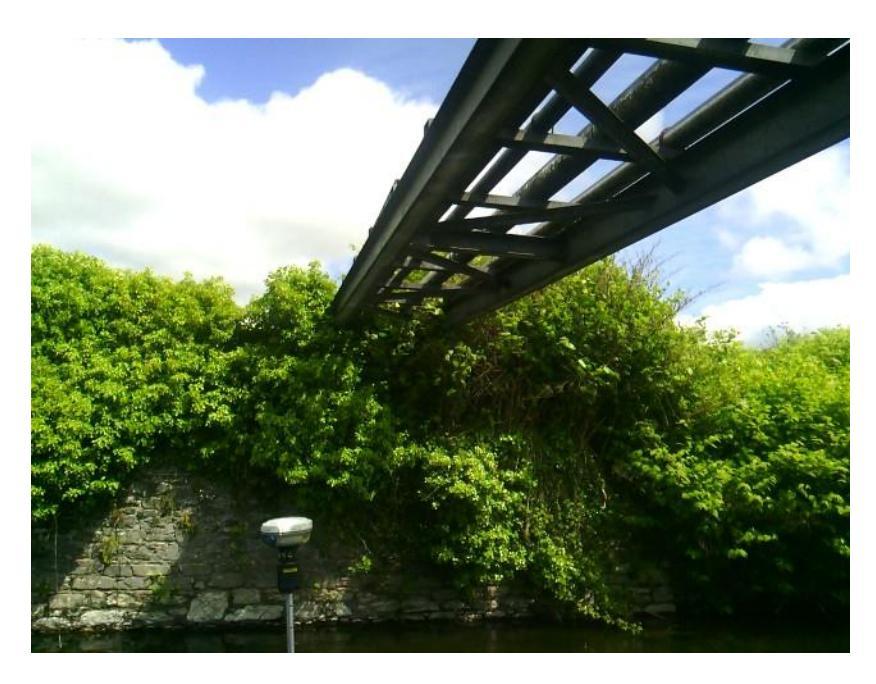
There is also an existing structure facilitating services crossing the Owenacurra circa 20m upstream of the rail line crossing (Figure 7) The design water level at this location (circa 7.2mOD) is approximately 2.2m lower than the underside of the structure (circa 9.4mOD). Therefore there is a very low risk of debris snagging and causing a potential blockage at this structure.

Figure 7 Structure facilitating services upstream of the railway line

However its removal as an interim measure (and the services be diverted if still in use) could provide a minor flood mitigation measure. The blockage risk versus the cost of the works should be evaluated in further detail.

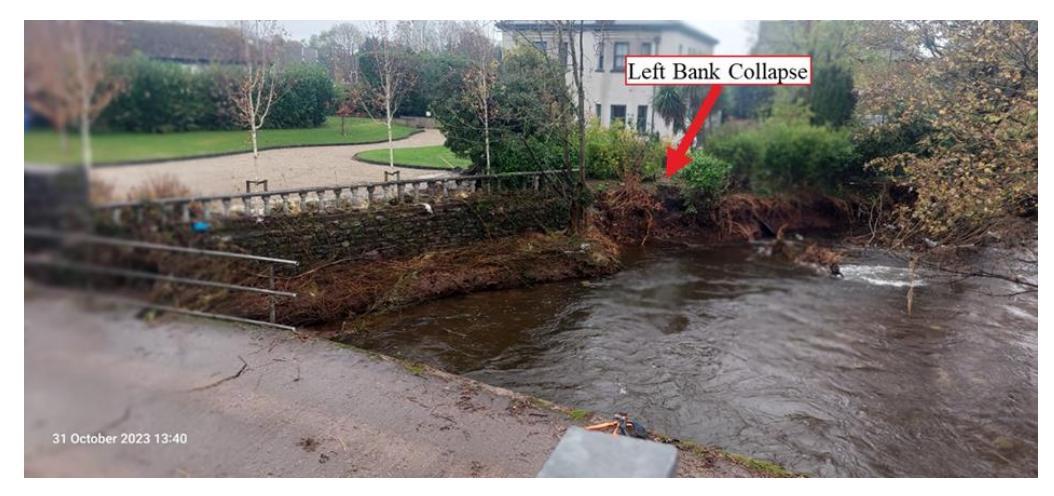
A section of the left bank downstream of Moore's Bridge collapsed (Figure 8) during Storm Babet. An analysis on the benefits of reinstating this section of bank back to pre-Storm Babet levels as part of the potential interim measures has been carried out.

Figure 8 Collapsed Left Bank Downstream of Moore's Bridge

Based on inspection of topographical survey data acquired before the storm event, the edge of bank immediately downstream of the ornamental wall shown in Figure 8 is circa 13.49- 13.33mOD. It is estimated that between 2m and 3m of the bank has been eroded over a length of approximate 15m. Survey taken post Storm Babet shows the edge of bank level is between 13.23 and 13.56mOD. As the ground rises behind the edge of bank, there is no impact on the threshold of flooding due to the erosion caused by Babet.

It is noted that the design water level (1% AEP event) in this area is circa 13.5mOD and is therefore greater than the elevations of certain sections of the bank. It is appropriate to mitigate/ manage further erosion risk in this area and it is recommended that the erosion in this area be monitored, and control measures put in place if required.

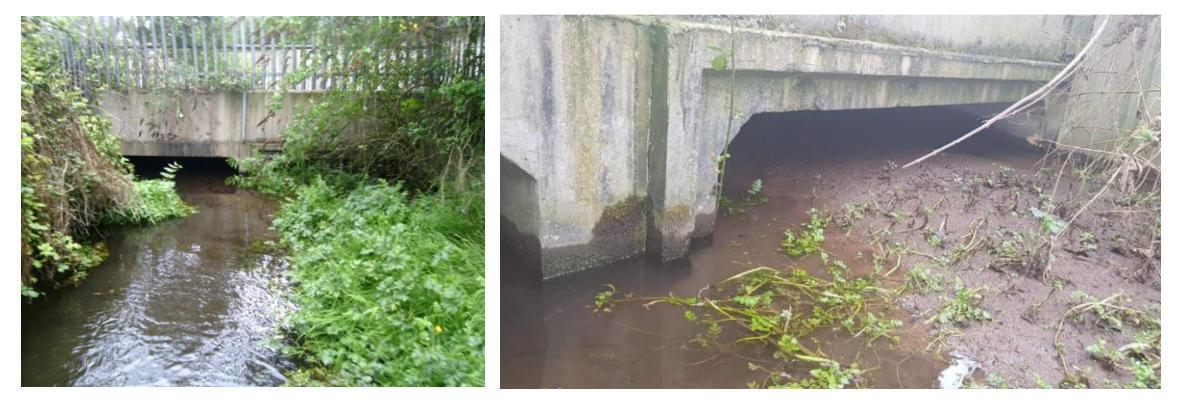
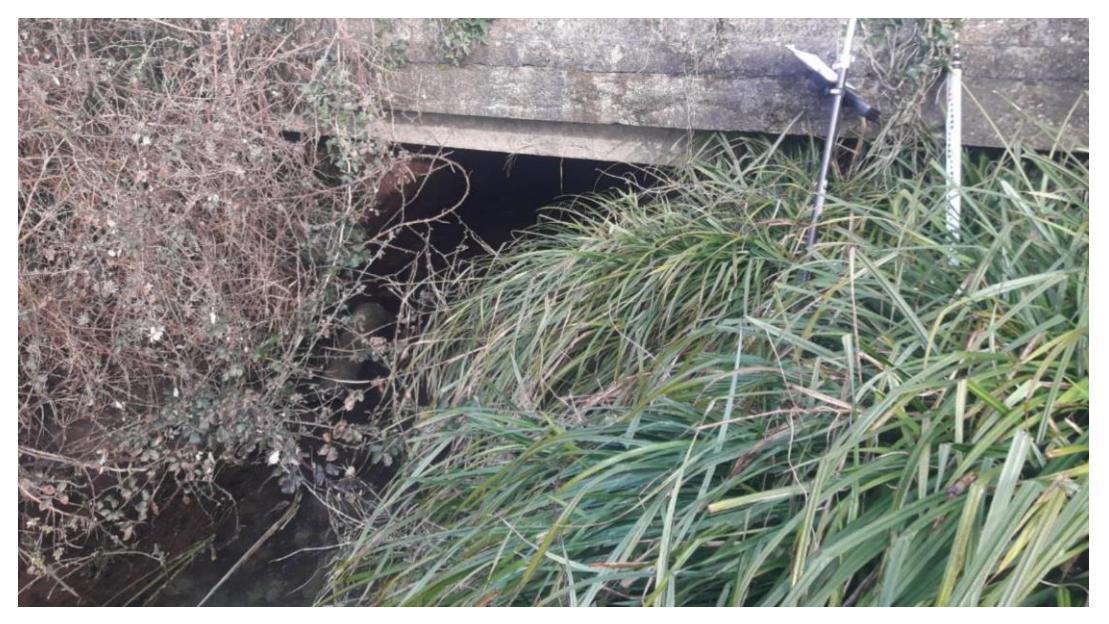
During the design flood event, water overtops the Millrace left bank at this location and travels in the direction of the Railway Cottages.

Figure 9 Photograph of the Millrace railway culvert - upstream face (July 2017, Murphys Surveys)

Figure 10 Downstream face of railway culvert on Millrace

As an interim measure, it is recommended that the sedimentation/ blockage risk in this area be addressed to mitigate against flooding. The environmental impacts of the removal of sedimentation/ in channel works will need to be considered and carried out at an appropriate time of the year to comply with various environmental constraints.

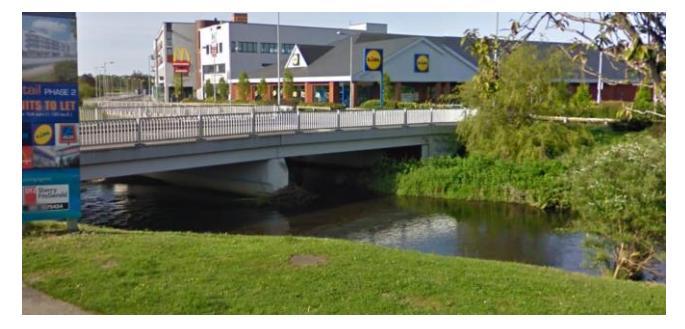
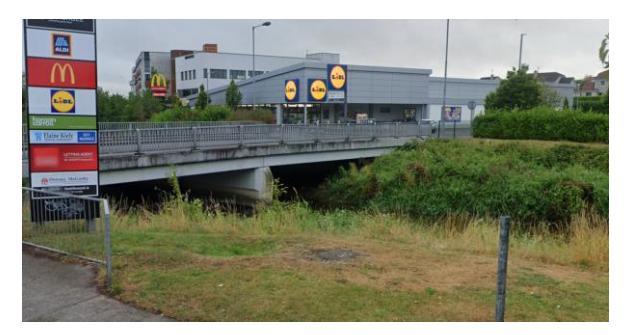
The right bank immediately upstream and downstream of the Lidl Bridge is heavily vegetated and is encroaching on the bridge opening which may impact the volume of flow being conveyed through the structure.

An inspection of historic Google Streetview images (Figure 12 and Figure 13) suggests that the vegetation build up has increased since May 2009. It is noted however that when comparing historic images, it is important to consider the time of year the images were taken as this will influence the vegetation. Management of this vegetation may increase conveyance through the Lidl Bridge and help reduce water levels during a flood event.

Figure 12 Comparison of vegetation buildup upstream of Lidl Bridge

It is noted that early in 2024 CCC sought quotations from suitably qualified contractors for vegetation clearance in this area but received no responses. CCC intend to retender these works again in the coming months, taking due cognisance of the seasonal restrictions on vegetation clearance.

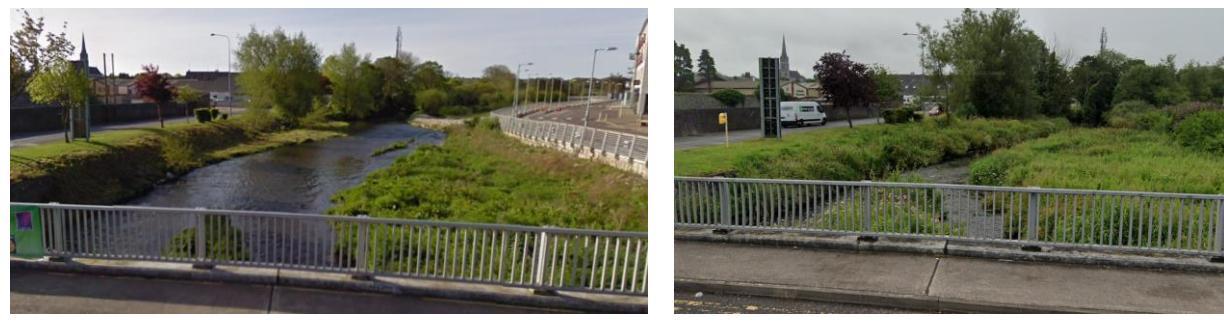
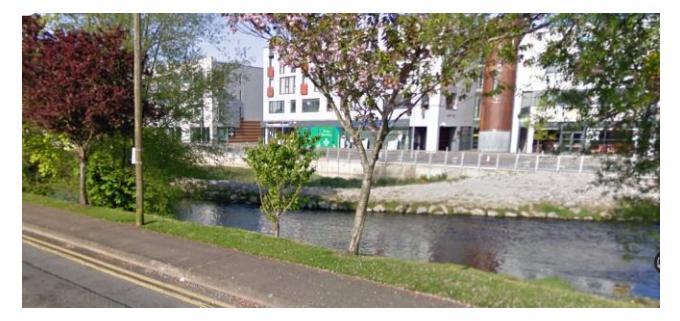
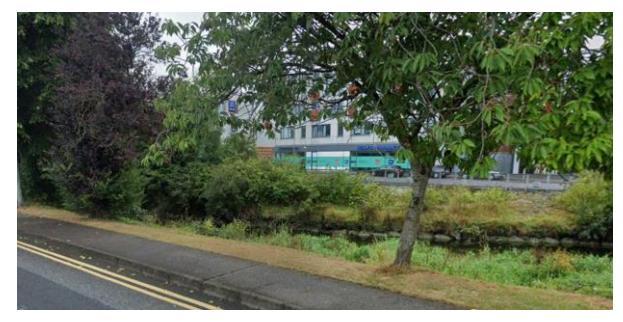
It is evident that since construction of this overflow system (Figure 14), there has been a very significant increase in vegetation across along the spill which will somewhat limit the volume of water that can overtop the spill. This in turn could limit conveyance in the low flow channel and lead to marginally higher water levels upstream of the spill.

Maintenance of this vegetation will marginally improve the hydraulic efficiency of the spill and hence improve conveyance through the reach.

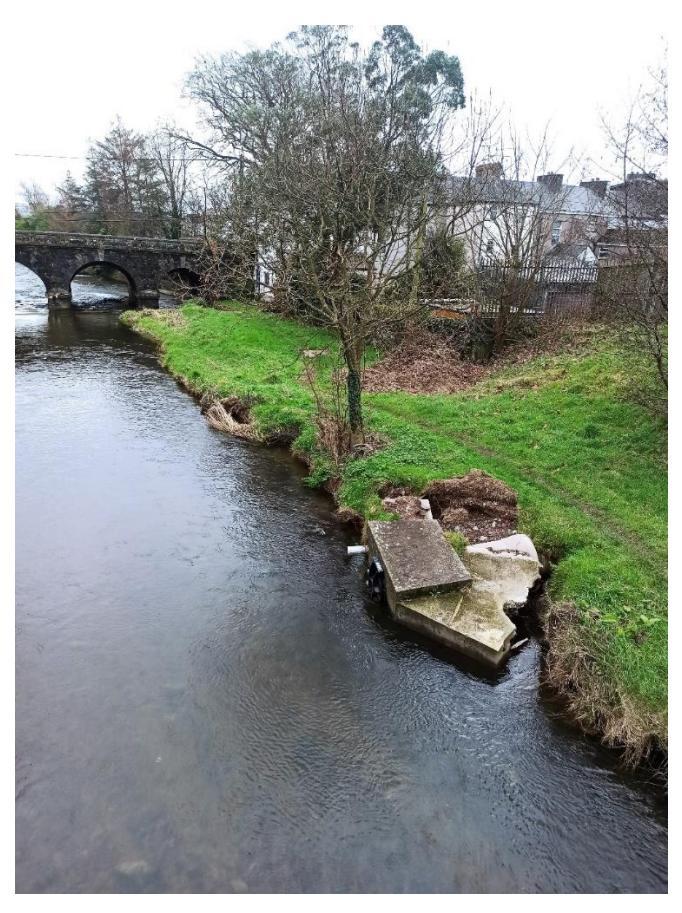
Pluvial water from the Market Green area discharges through an existing flap valve located approximately 10m downstream of the Market Green Bridge on the right bank. This is a private asset and is not in the control of CCC (or the OPW). The concrete surround of the flap valve has been undermined and has been detached from the bank as shown in Figure 15. From inspection it is unclear if the damage caused to the outfall allows the flap valve to be by-passed and for an egress of water to travel up the pipe during periods of high flow on the river. It is recommended that an inspection of this outfall be carried out by the appropriate party and repairs be made as required.

The damaged infrastructure also poses a blockage risk to the Cork Road Bridge circa 40m downstream if it were to become disconnected. Any in channel works need to consider potential environmental impacts and may need to be carried out at an appropriate time of the year.

It is noted that a second, smaller drain adjacent runs adjacent to the larger pipe and is secured within the same block.

Figure 15 Damaged outfall on right bank downstream of Market Green Bridge (image courtesy of Geoffrey Eastaway)

CCC has engaged with the owners of this asset, who have advised that repair works will be carried out during Summer 2024.

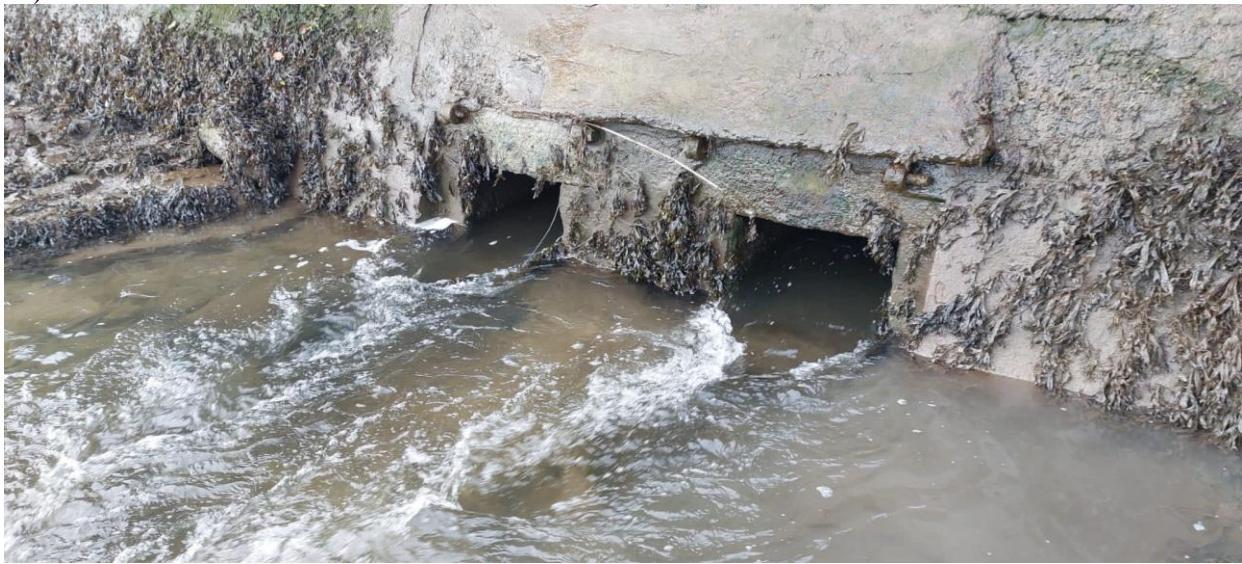
As a potential interim measure, it is recommended that the Water Rock Stream outfall into the estuary at the old sea wall be fitted with new non-return valves as the existing flap valves have been removed (see Figure 16).

Figure 16 Existing outfall of Water Rock Stream to Inner Estuary with flood doors removed (image provided by CCC)

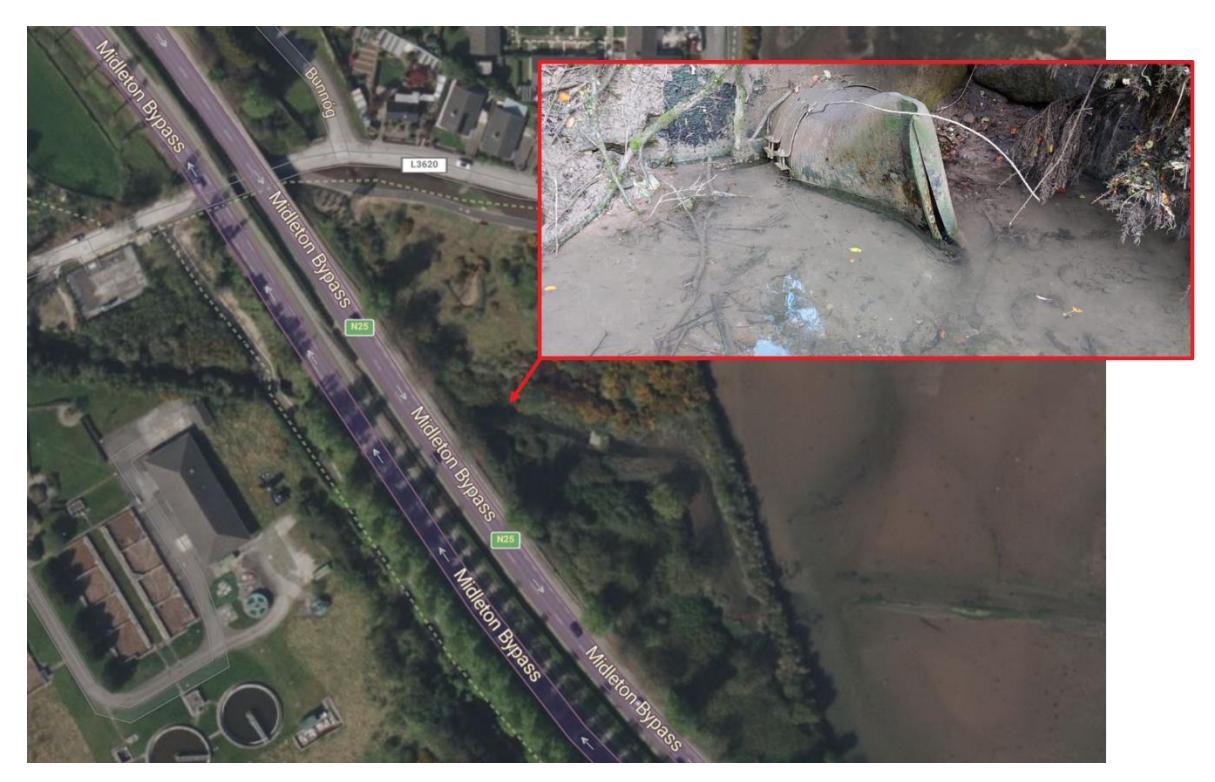
It is understood that there is also a storm water outfall from Dwyer's Road/ Bannog Estate discharging to the inner estuary which has been fitted with a non-return valve. The approximate location and an image of this outlet is shown in Figure 17. It is recommended that the condition of this valve be inspected and replaced if required.

Figure 17 Existing outfall of storm water outfall from Dwyers Road/ Bannog Estate (image provided by CCC)

Provision and maintenance of new flap valves will limit tidal waters egressing through the culverts. As the outlet is located close to the Cork Harbour SPA and the Great Channel SAC, environmental impacts of the works must be considered and due consideration to the statutory constraints.

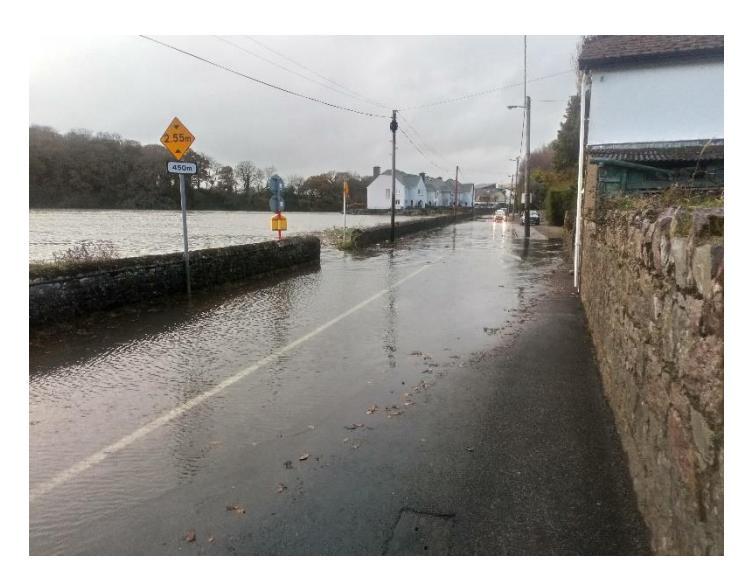
A break in the existing wall along the Bailick Road which facilitates access to a boat ramp allows for high spring tides to inundate Bailick Road. An image taken during a high tide is presented below.

Figure 19 Flooding of Bailick Road at high tide (Nov. 2020)

Regrading/changing the levels of the existing spill would increase the threshold of tidal flooding in this area and hence reduce the risk of tidal flooding to the road.

It is however noted that during the Storm Babet flood event, water from the town travelled south along the Bailick Road until it entered the estuary through the opening at the boat ramp. The impact of regrading on flow paths into the estuary for fluvial and pluvial flow would therefore need to be considered in the context of this release mechanism.

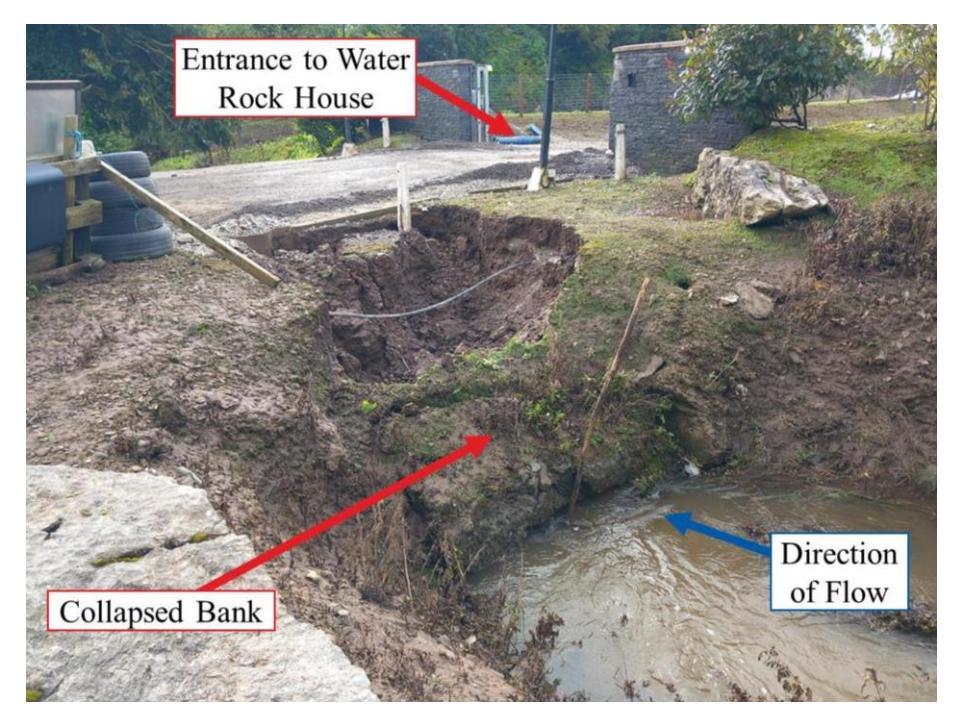
During the Storm Babet Flood Event, the bank upstream of the twin circular culvert arrangement passing under the Water Rock House access road collapsed, as shown in Figure 22. It is recommended that this bank is reinstated as part of any interim works for the scheme.

Figure 22 Bank Collapse Upstream of Culvert

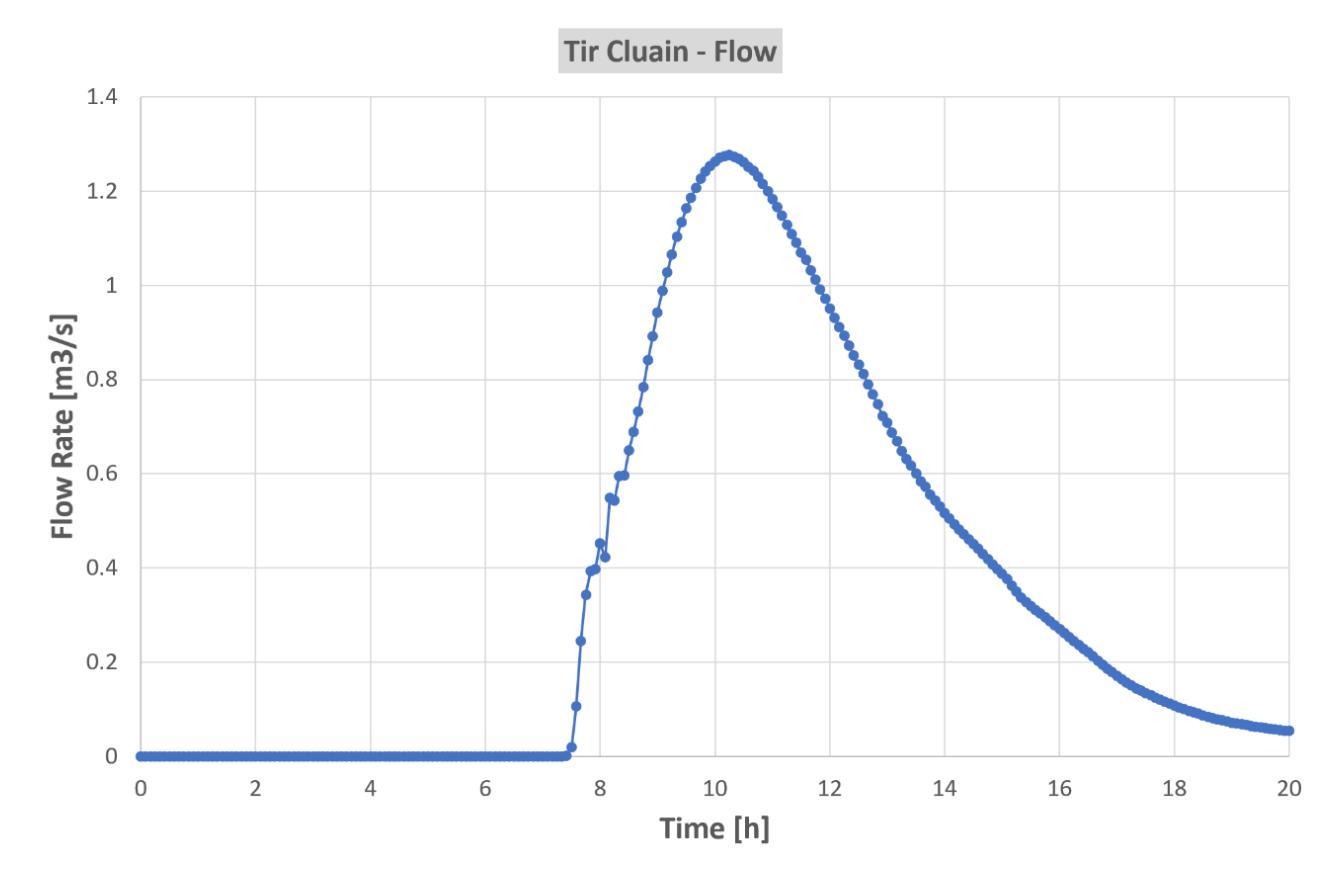
In order to assess the impact of defending Tir Cluain in isolation from the rest of the scheme (i.e. progressing it as advance works), we have calculated the total inflow into the estate from the Owenacurra for the existing scenario Q100 event.¹ The inflow hydrograph is presented in the figure below. It can be seen from the figure than the peak flow into the estate is circa $1.3m^3/s$ and the total volume of the hydrograph is circa $26,000m^3$. When compared with the total peak flow through the through the reach, the fraction of the flow entering the estate represents circa 2% of the total flow.

Figure 23 Total flow into Tir Cluain for the Q100 event

It can therefore be seen that while progressing advance works to protect Tir Cluain would offer the estate the SoP of the scheme, flood risk downstream may be increased as the storage offered by the estate would be removed and forced downstream.

As part of this report, we have not undertaken the detailed hydraulic modelling which would be required to quantify the impacts these advance works would have on water levels both downstream and upstream as well as in combination with other advance works which may also be considered. Detailed assessment will be required to determine the viability or otherwise of such measures. Should CCC and OPW wish to progress advance measures at Tir Cluain, it is recommended that this detailed assessment be carried out.

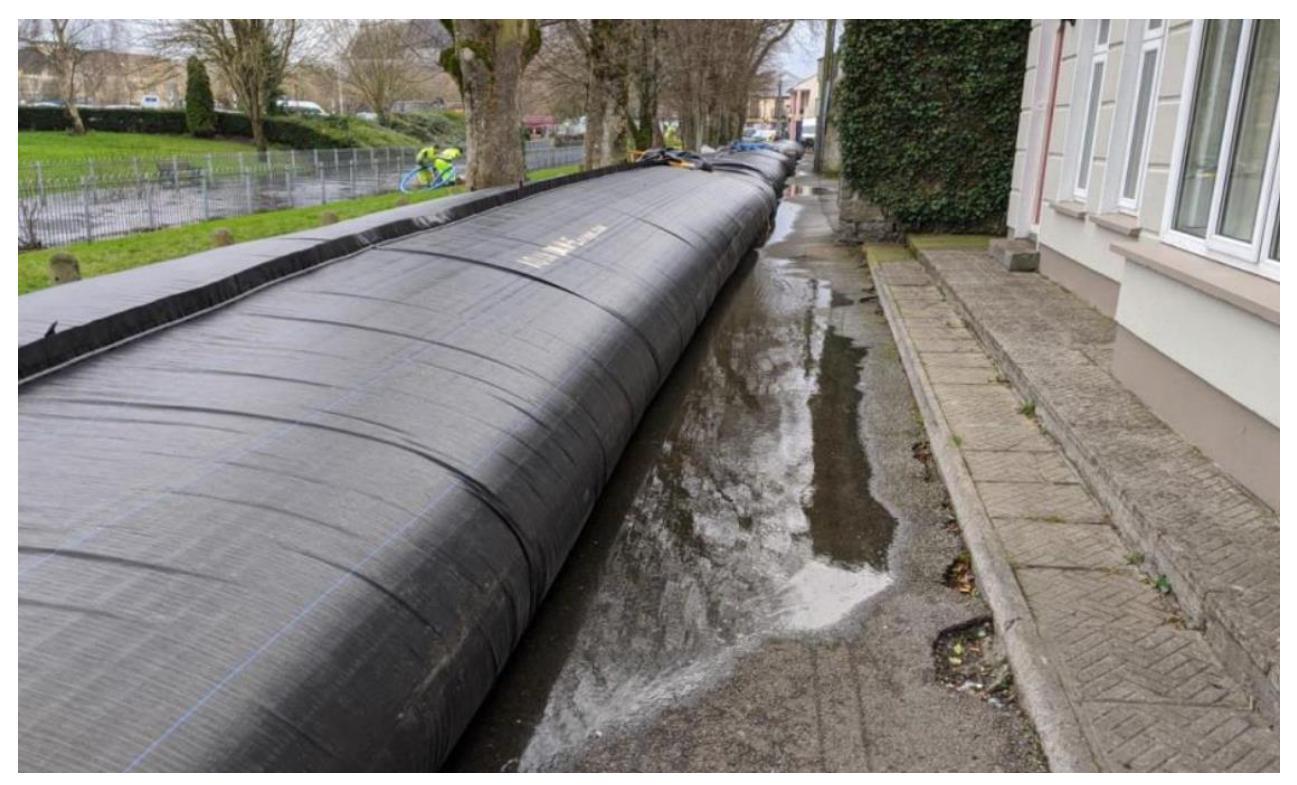
A temporary water-filled or air-filled barrier could also potentially be used in order manage flood risk. Such a measure is presently used by Galway County Council in Ballinasloe where a water filled temporary barrier 140m in length works in conjunction with a flood wall and the deployment of a demountable barrier to reduce flood risk to a number of properties in the town. An image of the deployed barrier is presented below.

Figure 24 Temporary water filled barrier in Ballinasloe

There would however be a number of difficulties in adopting a temporary barrier to reduce the flood risk to Tir Cluain. These can be summarised as:

- Residual risk of failure during an event;
- Ongoing operation and maintenance particularly if it is left in place for a prolonged duration;
- Tie in with high ground is likely to only be achieved by deploying sandbags at the end of the inflatable barrier in order to prevent water ingress around the barrier

- The need for an adequate warning time in order to successfully deploy the barrier an accurate flood forecasting system with an adequate lead in time would therefore be required to be developed as Midelton does not have such a system at the present time. Refer to Section 5 for further discussion on flood forecasting system. It is noted however that this issue could be addressed by leaving the barrier in place for a long duration of time i.e. over the winter months.

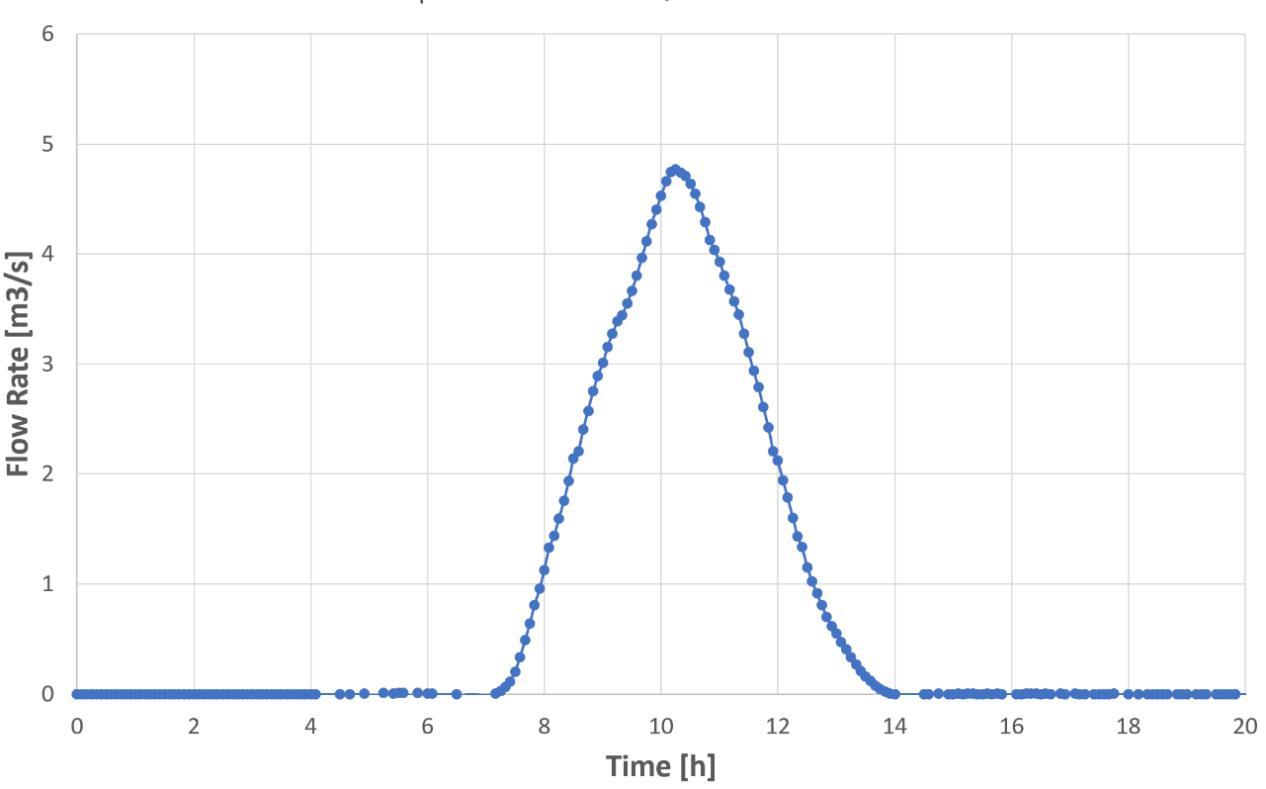
In order to assess the impact of progressing this element of the scheme as advance works, we have calculated the total overflow hydrograph for the existing scenario Q100. The hydrograph is presented in the figure below. It can be seen from the figure than the peak out of bank flow from the river at this location is circa 4.8m³/s and the total volume of the hydrograph is circa 55,000m³. When compared with the total volume of water through the reach the fraction of the flow leaving the river at this location represents circa 5.8%.

Upstream of NRR - Q over left bank

Figure 25 Total flow out of the left bank upstream of the NRR

Due to the removal of the storage offered by the existing floodplain, flood risk downstream may be increased. As noted in the section above we have not undertaken the detailed hydraulic modelling which would be required to quantify the impacts of any such advance works. Should CCC and OPW wish to progress advance measures at this location, it is recommended that this detailed assessment be carried out.

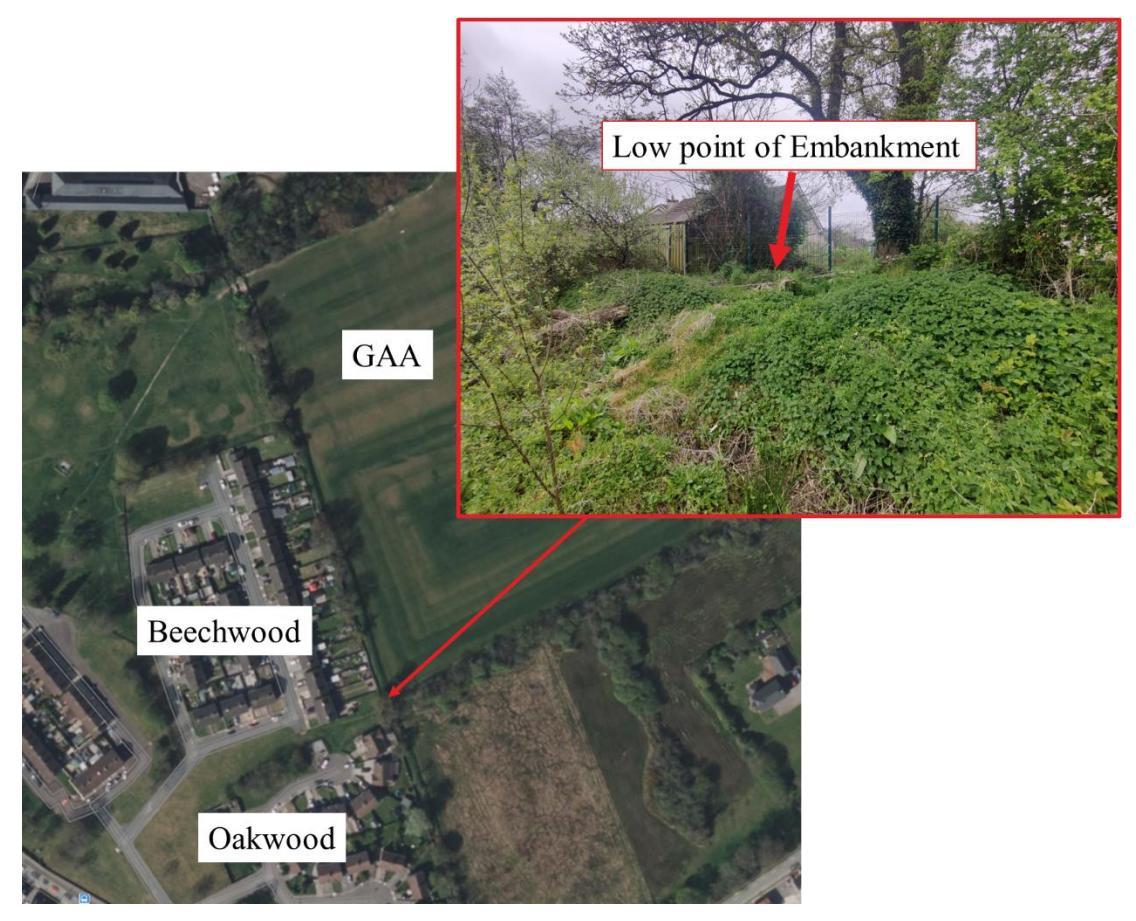
As part of the GAA grounds redevelopment works, it is understood that an informal earthen embankment was placed parallel to the rear wall of the Beechwood and Oakwood Estates. This embankment offers protection for low return period events. However, there is a low point of circa 15m in this embankment between the South of Beechwood Drive and the North of Oakwood Lodge as shown in Figure 26. Arup conducted a site walkover to confirm the location of this low point. As an interim measure, it may be possible to undertake works to infill the low point and increase the standard of protection of the embankment. This would reduce flood risk to the estates in the present day.

Figure 26 Low point of existing GAA informal embankment

Temporary defences are not likely to be high enough in order to defend the properties in these estates and for this reason are not deemed to be viable.

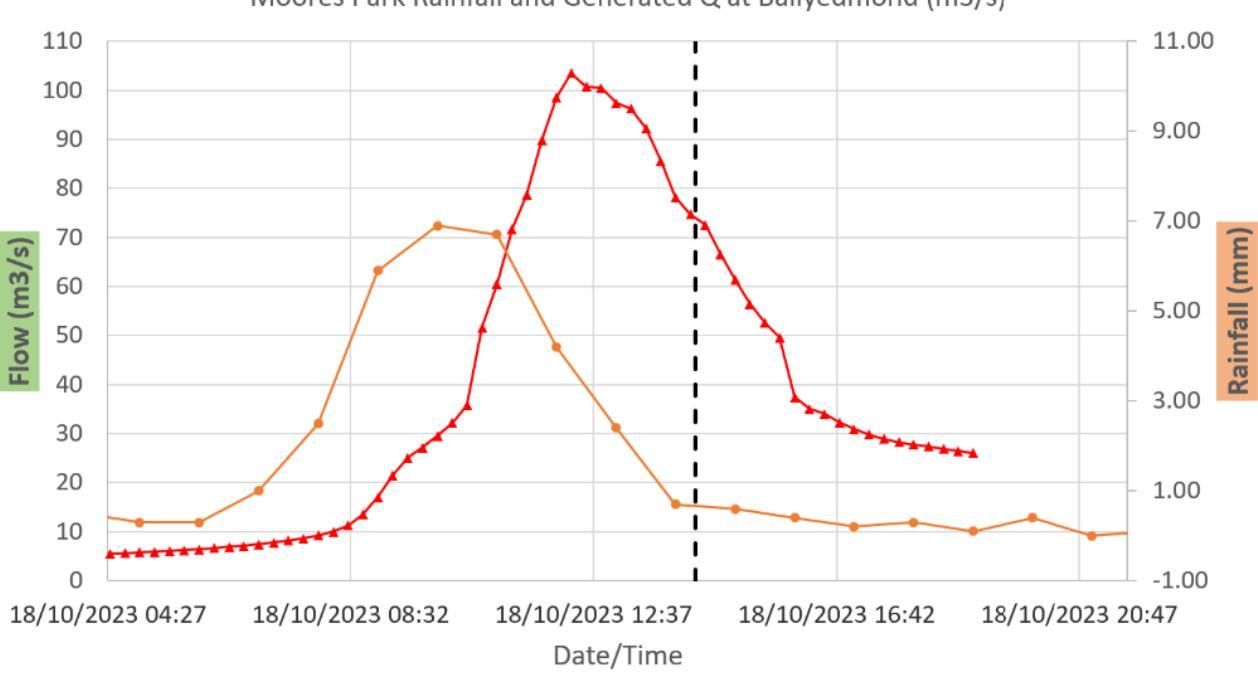
It can be seen from the figure that the flood wave at Ballyedmond (shown in red) started to rise at circa 10:30am on the 18th October and peaked at 12.15pm. The time to peak was therefore less than 2 hours. This rate of rise is extremely rapid and aligns with the experiences of property owners during the event who stated that the onset of flooding was extremely rapid leaving them with no time to prepare.

Moores Park Rainfall and Generated Q at Ballyedmond (m3/s)

----Ballyedmond Rec Q -- Time of peak in town ----Rainfall depths at Moores Park
