## **Environmental Impact** Statement

#### **GLASHABOY RIVER (GLANMORE/SALLYBROOK) DRAINAGE SCHEME EIS**

#### PROPOSED TREES TO BE REMOVED

**Glashaboy River (Glanmire and Sallybrook) Drainage Scheme**

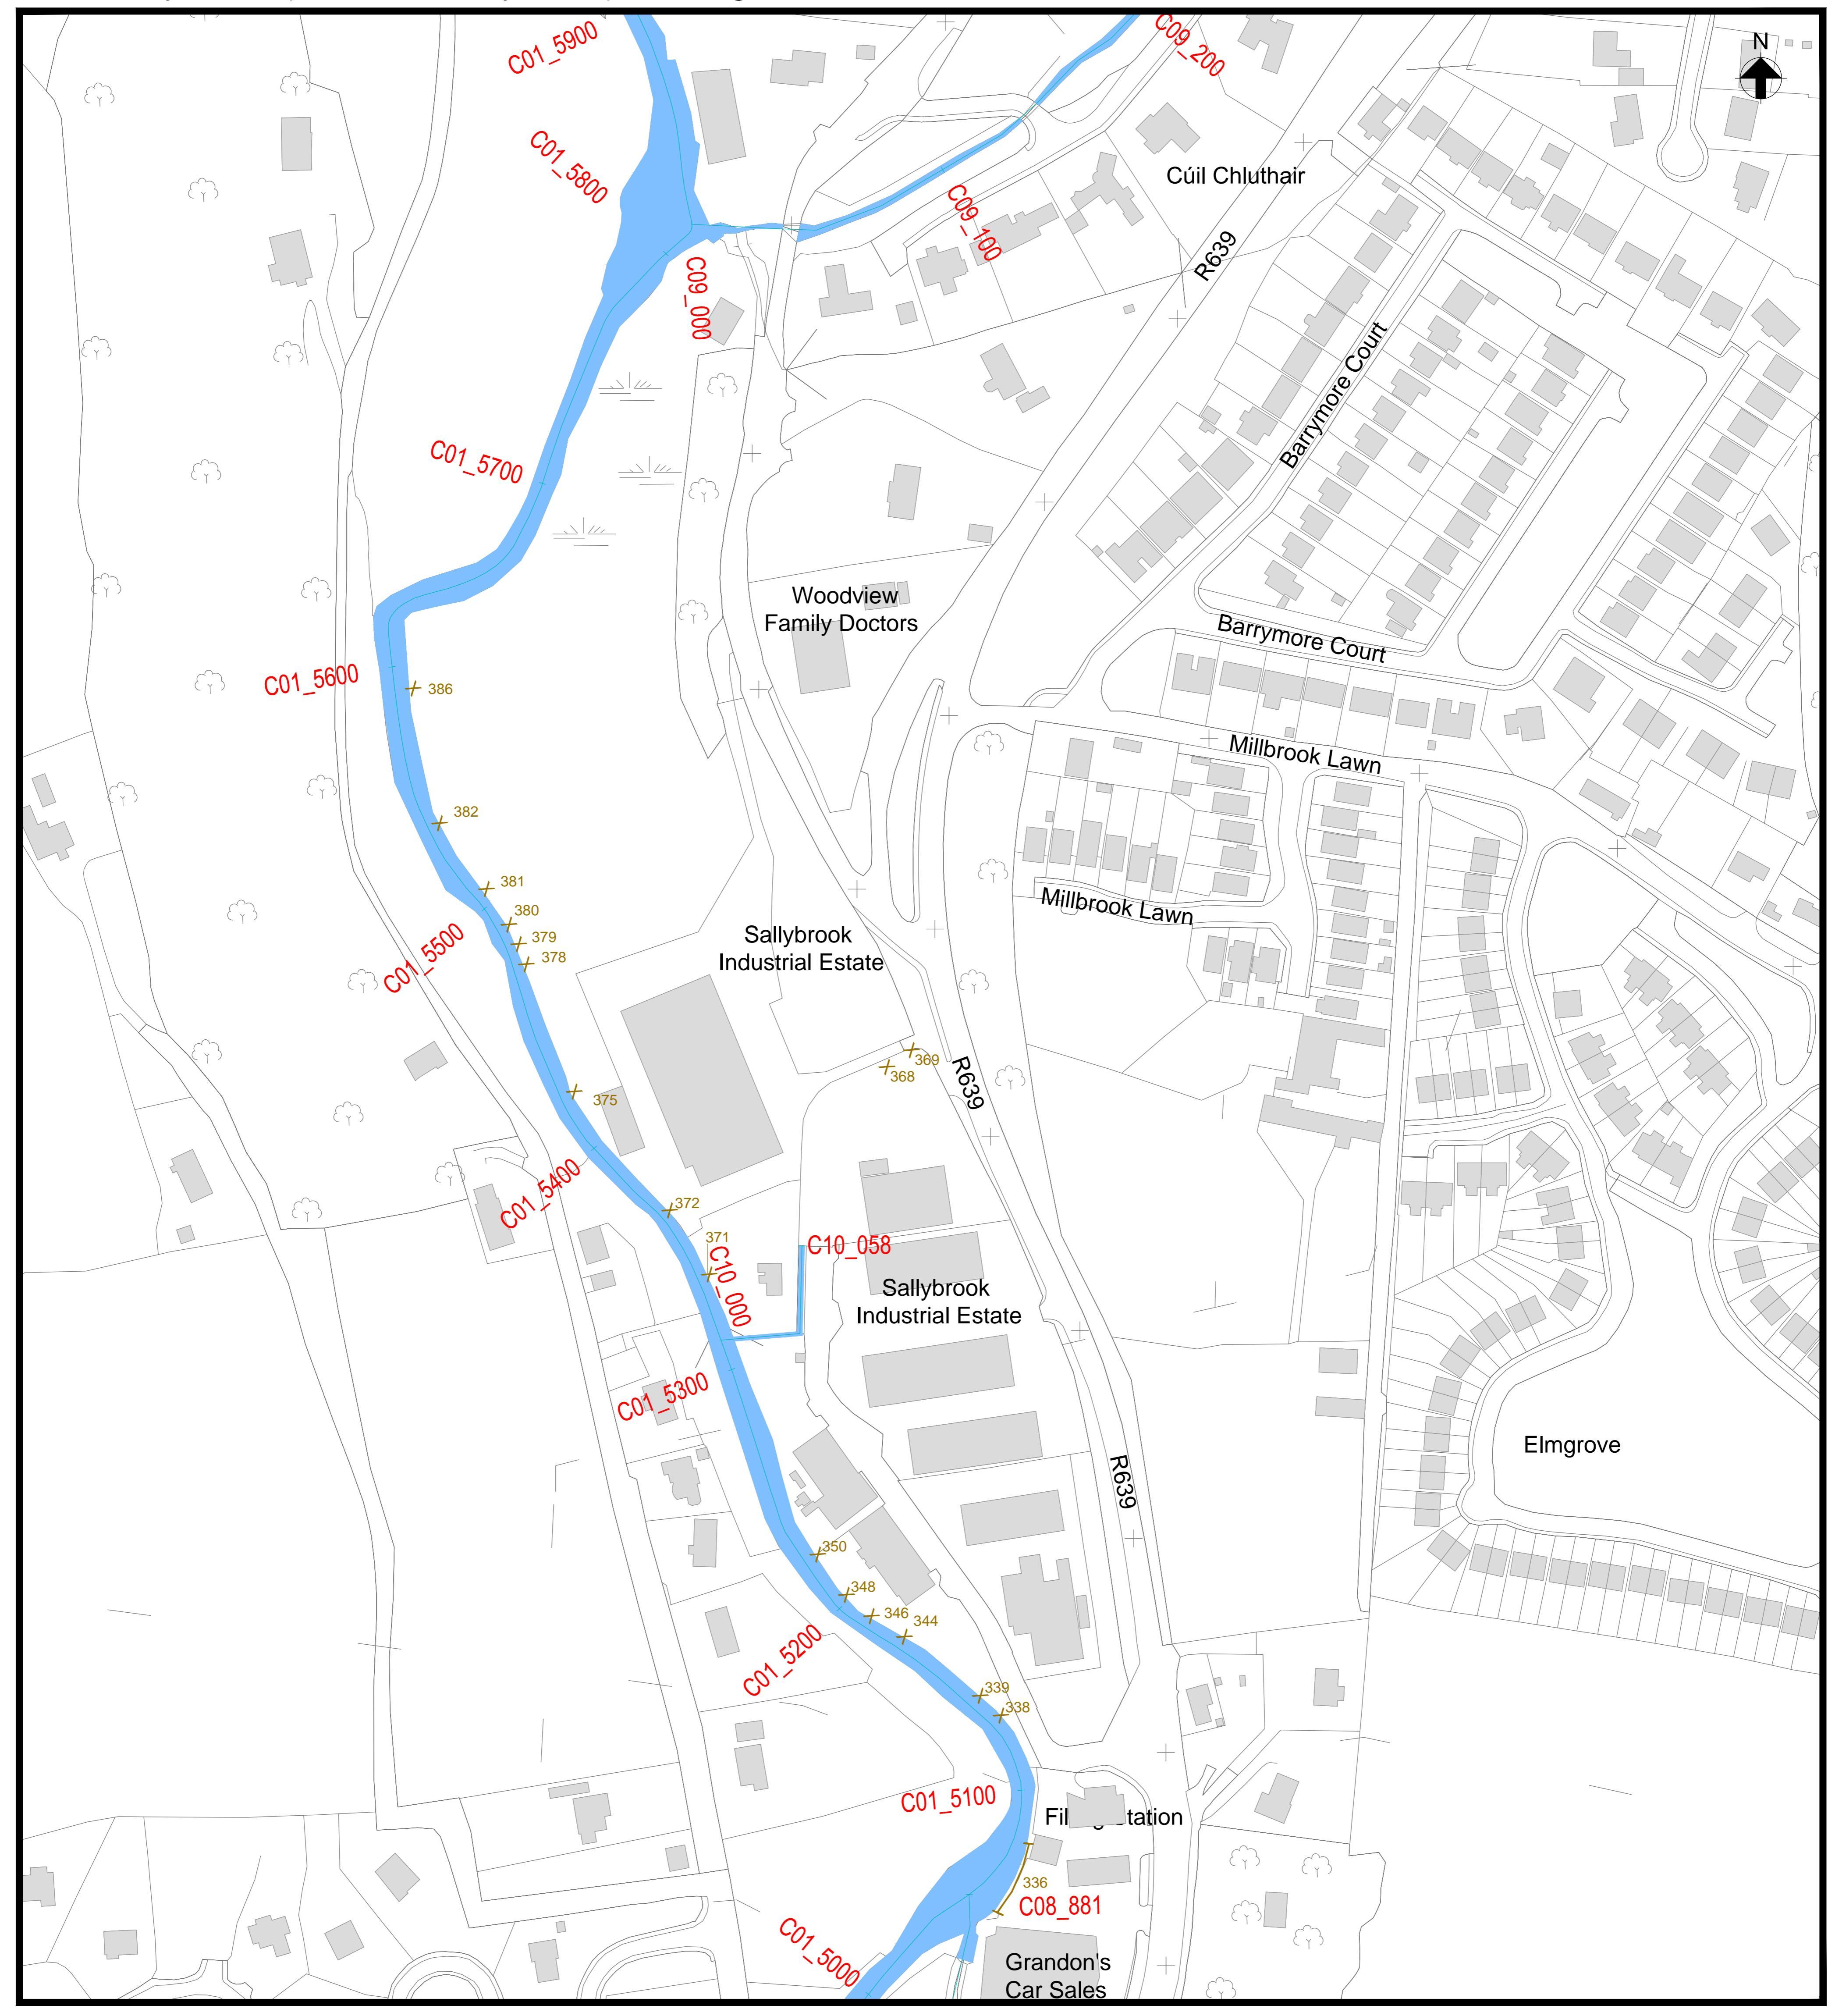
Drg. No. GR\_701 Proposed Trees to be removed - Plan Layout (Sheet 1 of 4)

Following the results of the survey, the Arup environmental and engineering teams modified the design where possible to avoid trees where feasible. The drawings and table presented in this Appendix show just the trees which are proposed to be removed to facilitate the drainage scheme.

## SALLYBROOK – UNNAMED CHANNEL Read in conjunction with Drawing GR\_701 Tree Survey

## SALLYBROOK – GLASHABOY RIVER Read in conjunction with Drawing GR\_701 Tree Survey

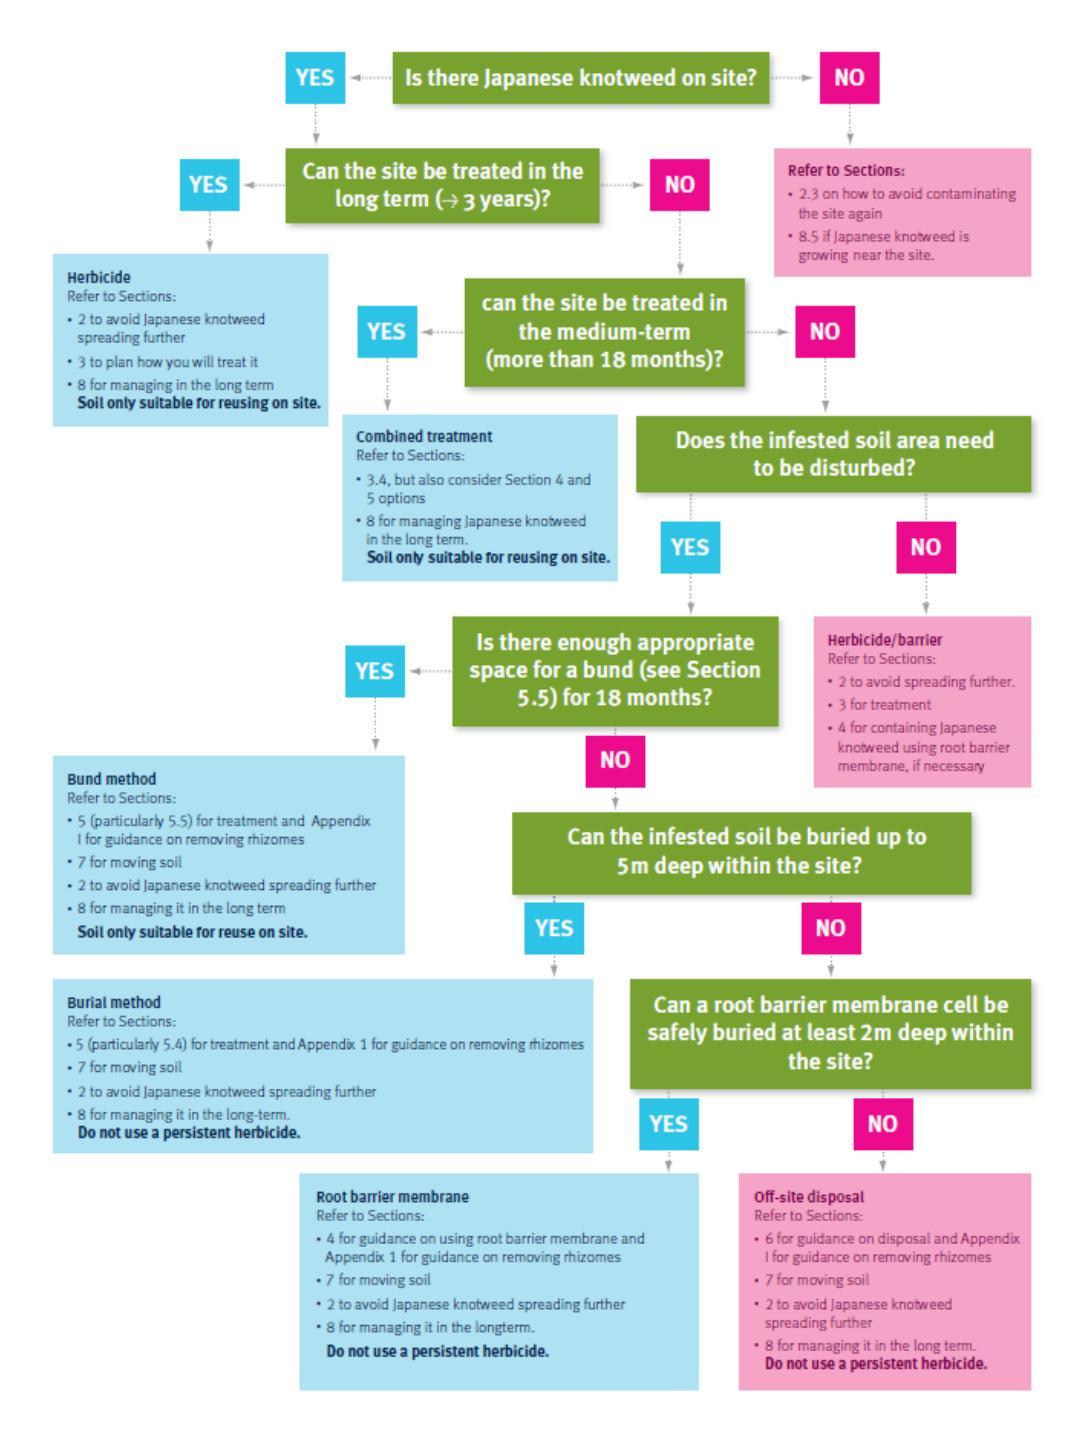
Figure 1. Flowchart for treating Japanese knotweed (Environment Agency, 2013).

**Figure 1** provides an example of a simple flow chart that may be used in the process of forming a management plan.

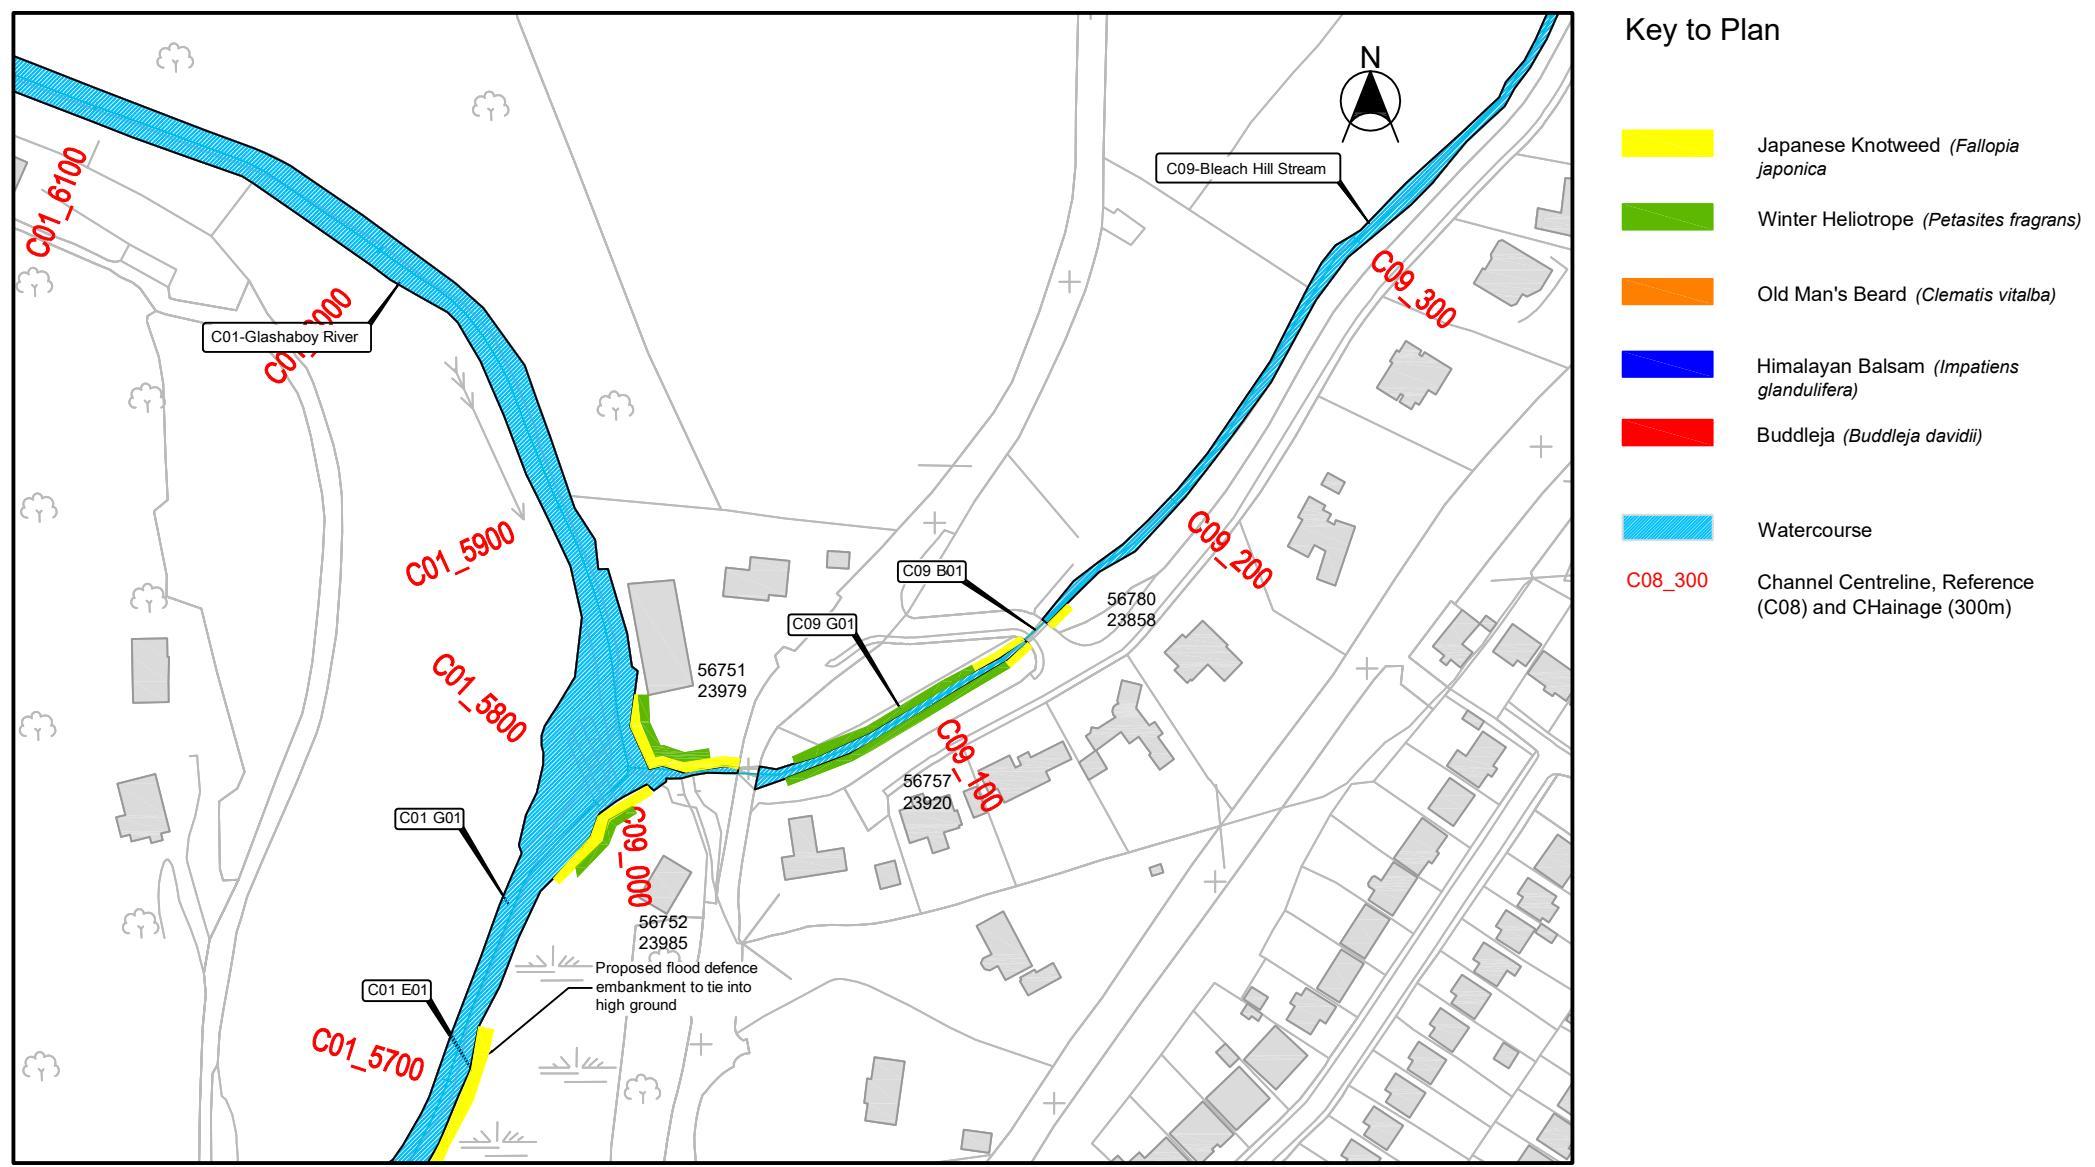
DRG. NO. GR\_201 Invasive Species - Plan Layout

The drawings appended to the end of this report show the locations of invasive species, including Japanese Knotweed within the works area in September 2016. Refer to Drawings GR\_201 to GR\_219 in **Appendix A**.
